Appendix D Cliff and Slope Instability Walkover Field Survey

From:	Madelaine Broadfoot, Paul Donaldson	To:	Kiama CMP Team
Date:	22 November 2019	CC:	Byron Robinson
Subject:	Geomorphological Walkover Field Survey and Preliminary Cliff/Slope Instability Exposure Assessment: Kiama's Rocky Coastline

1.1 Overview

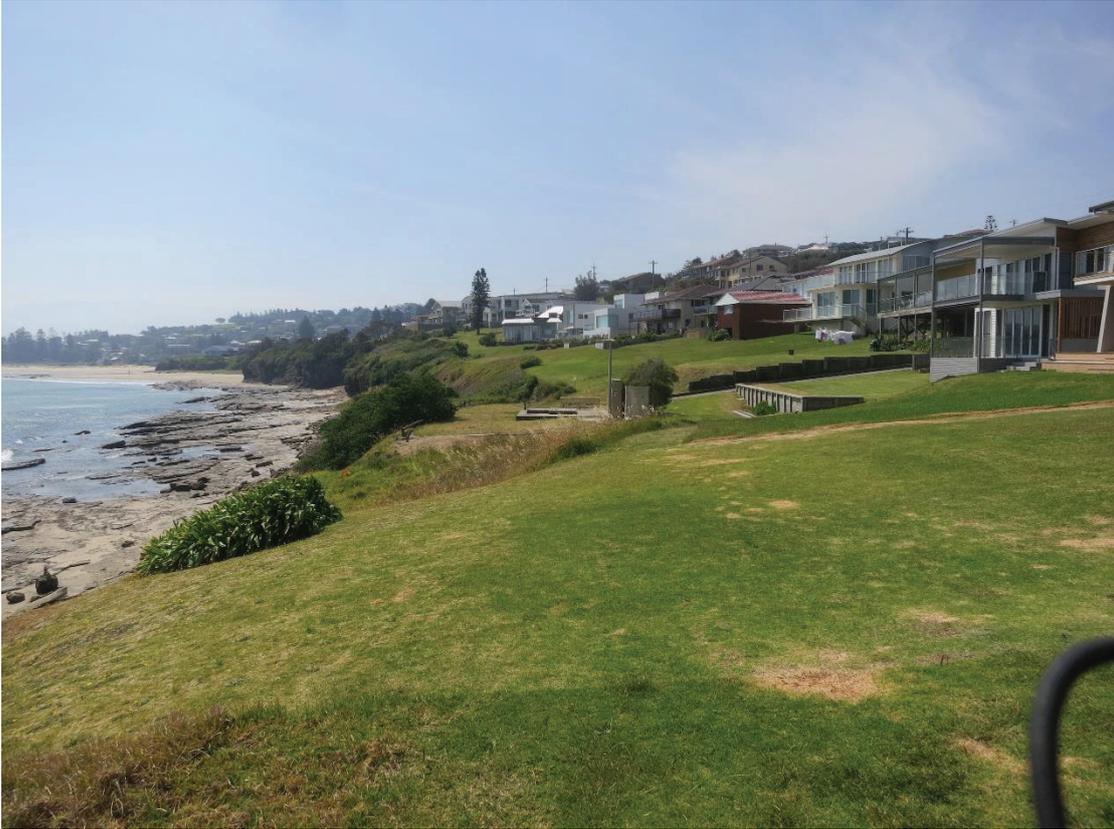
Land fronting the sewerage pump station on the western side of Black Head appears disturbed, it is recommended that the slope stability be monitored. The sewerage pump station on the eastern side of Black Head is situated on a weathered bedrock slope, that is fronted by a (potentially depositional) wide grassy terrace, some 5 metres above sea, it is recommended that the slope and erosion stability be monitored.

Figure 2 Pumping Station on Stafford St, on the western side of the headland

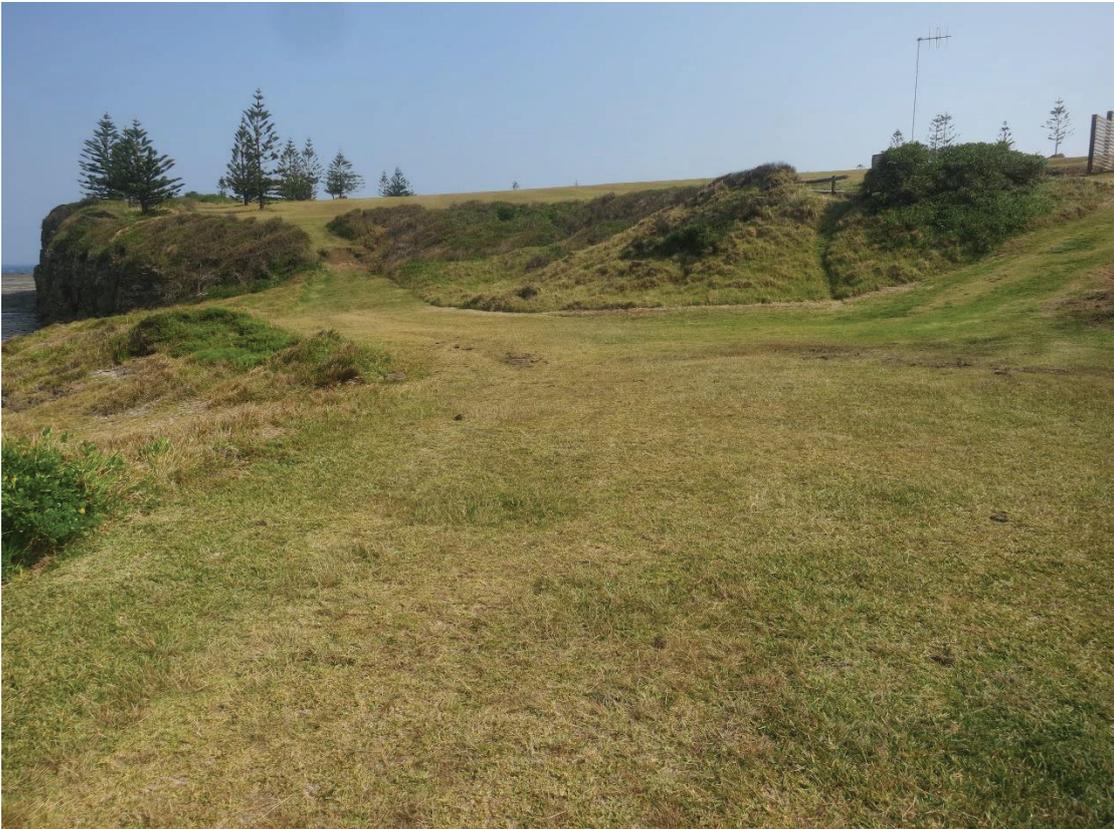
Figure 3 Sewage pumping station off Headland Dr, on eastern side of headland

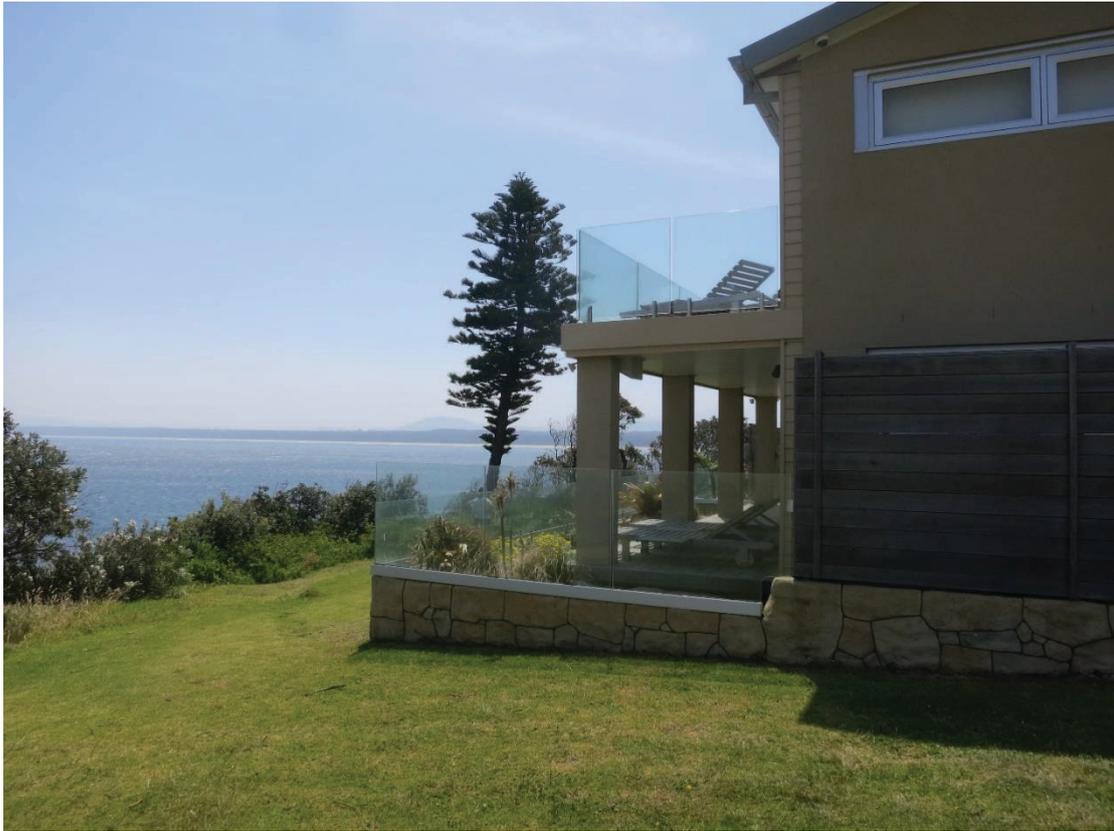
Properties on Stafford St near Black head reserve are close to the cliff edge, where bedrock is highly fractured and localised cliff regression rates look to be higher than elsewhere. New development or extensions proposed for this area should require geotechnical assessment, especially where allotment boundaries are in close proximity to cliff line. Additionally, residents should monitor dwellings for signs of movement (e.g. formation of crack in brick work).

Figure 4 Property located near localised cliff regression

Residential Asset: Stafford St	Require a Geological Survey of NSW (GSNSW) approved geotechnical assessment for new development or extensions proposed at 104 and 102 Stafford Street, where allotment boundaries are in close proximity to cliff line. Residents can monitor dwellings for signs of movement (e.g. formation of crack in brick work)
Residential Asset: Burke PDE	Monitor erosion of adjacent shoreline. This could include shoreline change analysis using historic and current aerial imagery. Formalised toe protection works may be warranted.
Infrastructure: Road Burke PDE	As above.

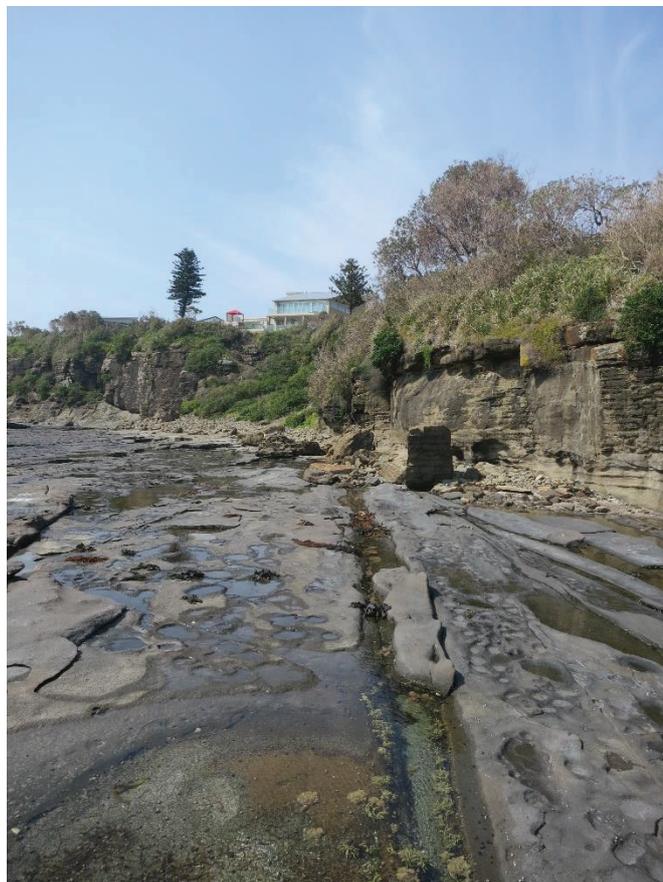
Figure 5 Fractured bedrock near Stafford St properties

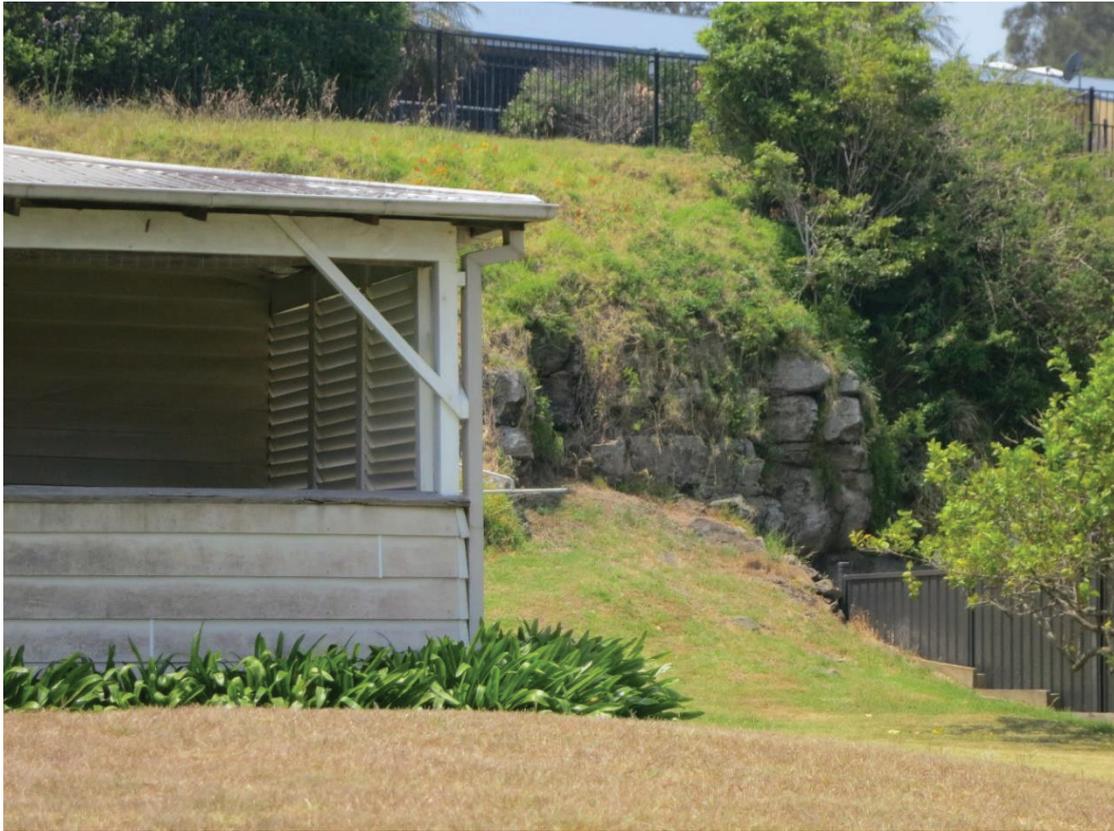
Burke Pde and some properties on this road are positioned on a low-lying terrace formed of alluvial/colluvial sediments, in front of bedrock cliffs, the land is possibly exposed to undercutting and slumping by wave action. Erosion of adjacent shorelines should be monitored, and formalised toe protection works may be warranted after a more detailed geotechnical investigation is conducted.

Residential Asset: Stafford St	<p>Residential properties on Stafford St near Black head reserve</p> <ul style="list-style-type: none"> Residential houses located close to cliff edge, where localised cliff regression rates look to be higher than elsewhere (Figure 4) Bedrock highly fractured in this location, as per Figure 5
Residential Asset: Burke PDE	<ul style="list-style-type: none"> Some Burke Pde houses position on low lying terrace formed of alluvial/colluvial sediments, in front of bedrock cliffs (Figure 6). Land possibly exposed to undercutting and slumping by wave action.

Figure 6 Burke PDE foreshore houses on low lying erodible land, fronting bedrock cliffs

Geotechnical Summary	
Infrastructure: Road, Burke PDE	<ul style="list-style-type: none"> Road in close proximity to the shore, located on low lying land formed of alluvial/colluvial sediments, as seen in an erosion escarpment (Figure 7). Possibly exposed to undercutting and slumping by wave action
Recommendation	
Infrastructure: Sewerage Pump Station (western side of headland)	Monitor slope stability through routine spot checks multiple times a year. This could include monitoring for evidence of slope movement (e.g. cracking in station foundation), a site specific geotechnical assessment is warranted, if this occurs.
Infrastructure: Sewerage Pump Station (eastern side of headland)	Monitor erosion and slope stability through routine spot checks multiple times a year, and aerial imagery analyses. This could include monitoring for evidence of slope movement (e.g. cracking in station foundation), or obvious landward shoreline changes (of the fronting terrace) observed in the aerial imagery. A site-specific geotechnical assessment is warranted, if any of these conditions occur.

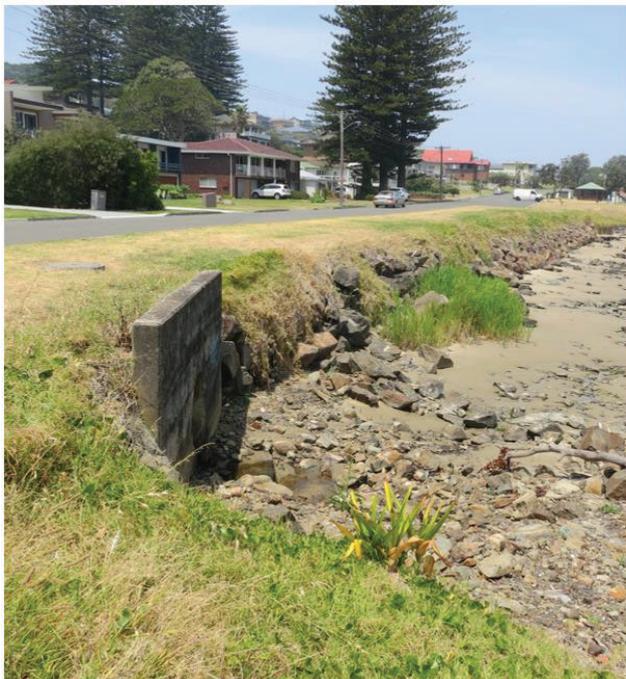
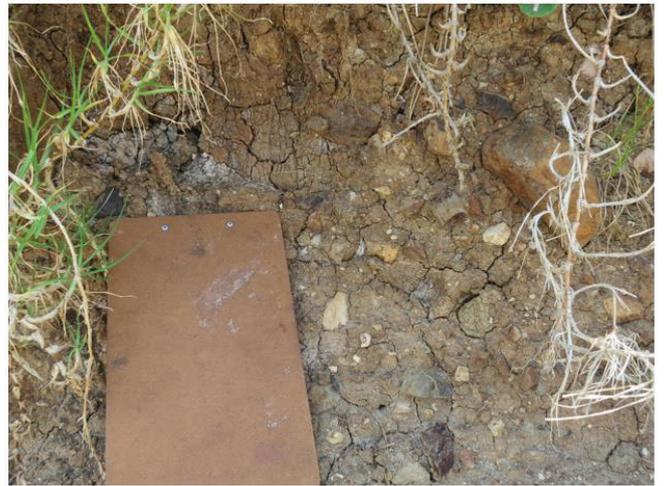
Figure 7 Unconsolidated exposed sediments forming low lying terrace at Burke PDE

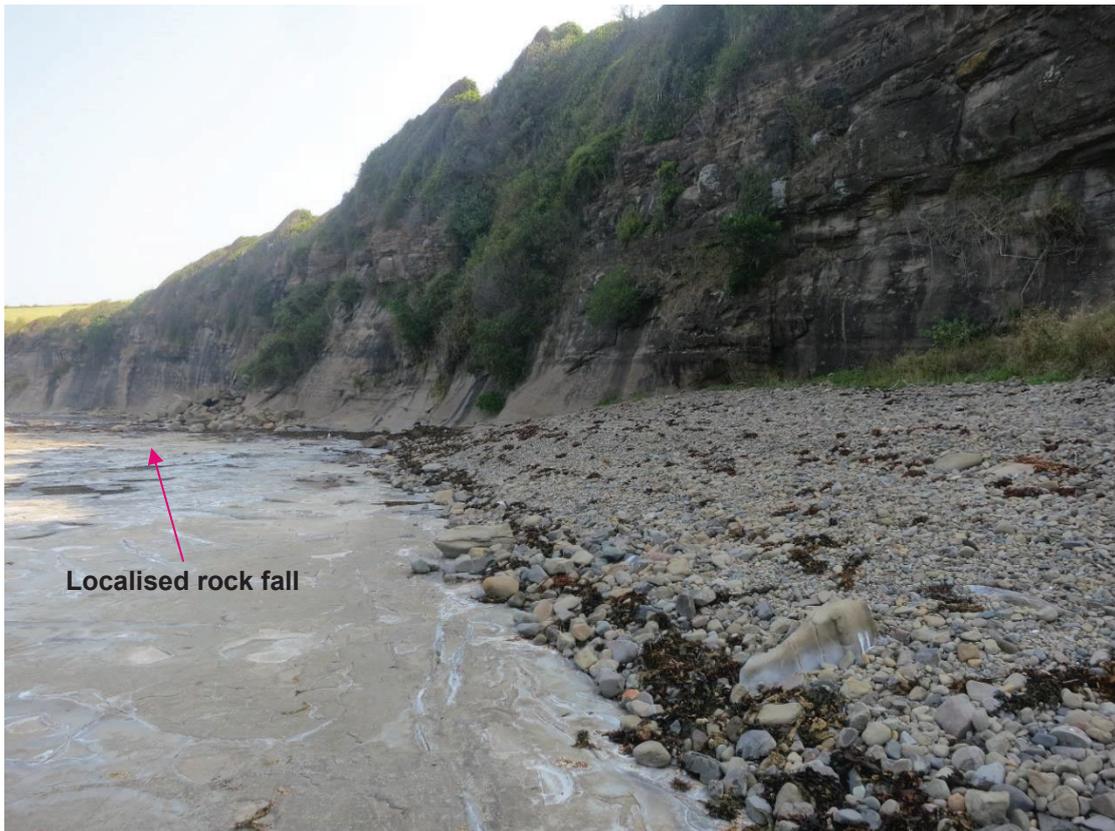
Figure 10 Localised rock fall at southern end of Gerringong Harbour

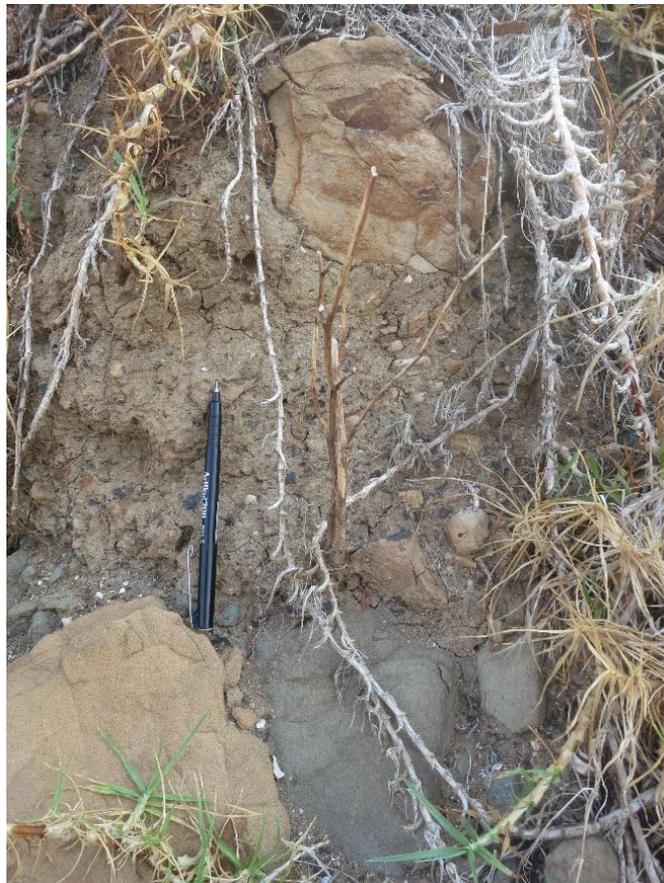
The southern Werri Beach car park appears to be built on colluvium and exposed to wave, undercutting and slumping due to storm wave action (see Section 3). The adjacent shoreline to the car park should be monitored for erosion, if shoreline erosion occurs and threatens the car park asset, a more detailed geotechnical assessment may be warranted to determine the erosion susceptibility of the car park. Additionally, a more formalised toe protection works of the car park fronting the rocky slopes, may be warranted (as there appears to be some ad hoc / previous structure already there).

Figure 12 Colluvium sediment that the south Werri Beach car park is built upon

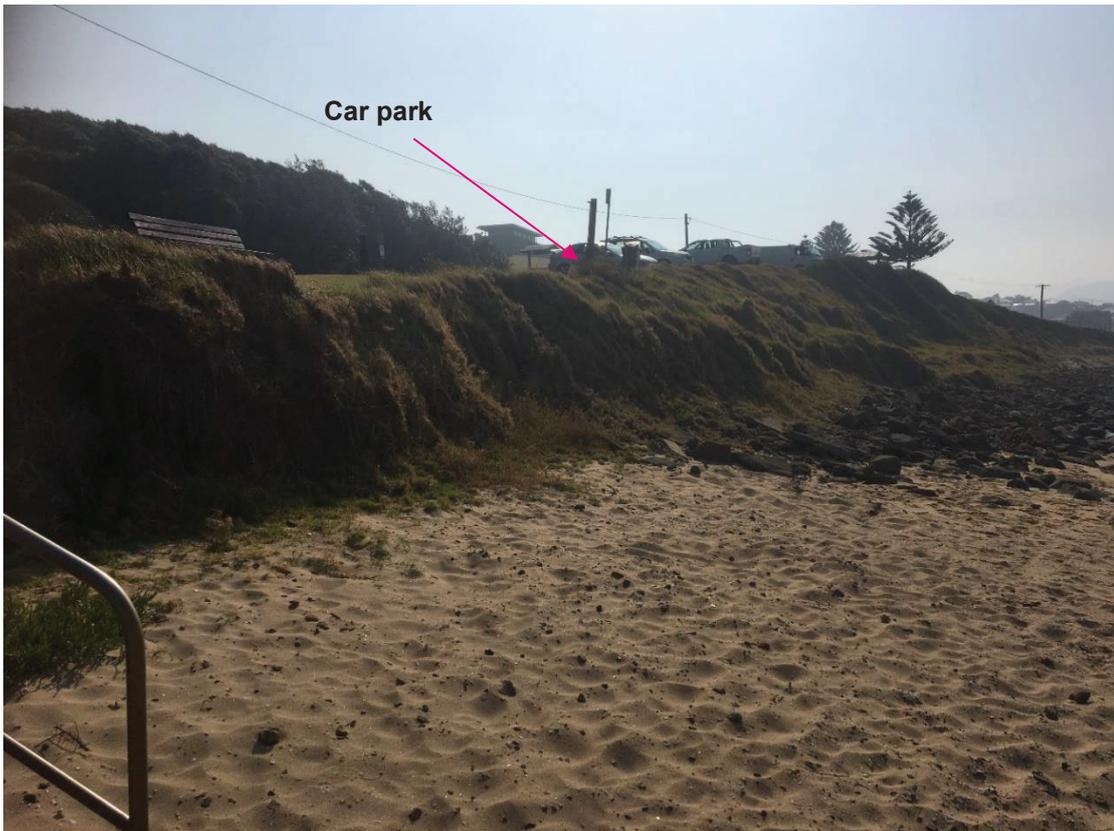
Figure 13 South Werri Beach car park

Geotechnical Summary	
	<ul style="list-style-type: none"> Formalised toe protection works of the car park fronting the rocky slopes, may be warranted.
House on Geering St	<ul style="list-style-type: none"> Require a geotechnical assessment for new development or extensions proposed where allotment boundaries adjoining the bluff slopes are located adjacent coastal hazard zones. Residents can monitor dwellings for signs of movement (e.g. formation of crack in brick work)
Road, foot path and car park on Pacific Ave	<ul style="list-style-type: none"> Monitor erosion of adjacent shoreline. If shoreline erosion occurs and threatens the car park asset, a more detailed geotechnical assessment may be warranted to determine the erosion susceptibility of the car park.

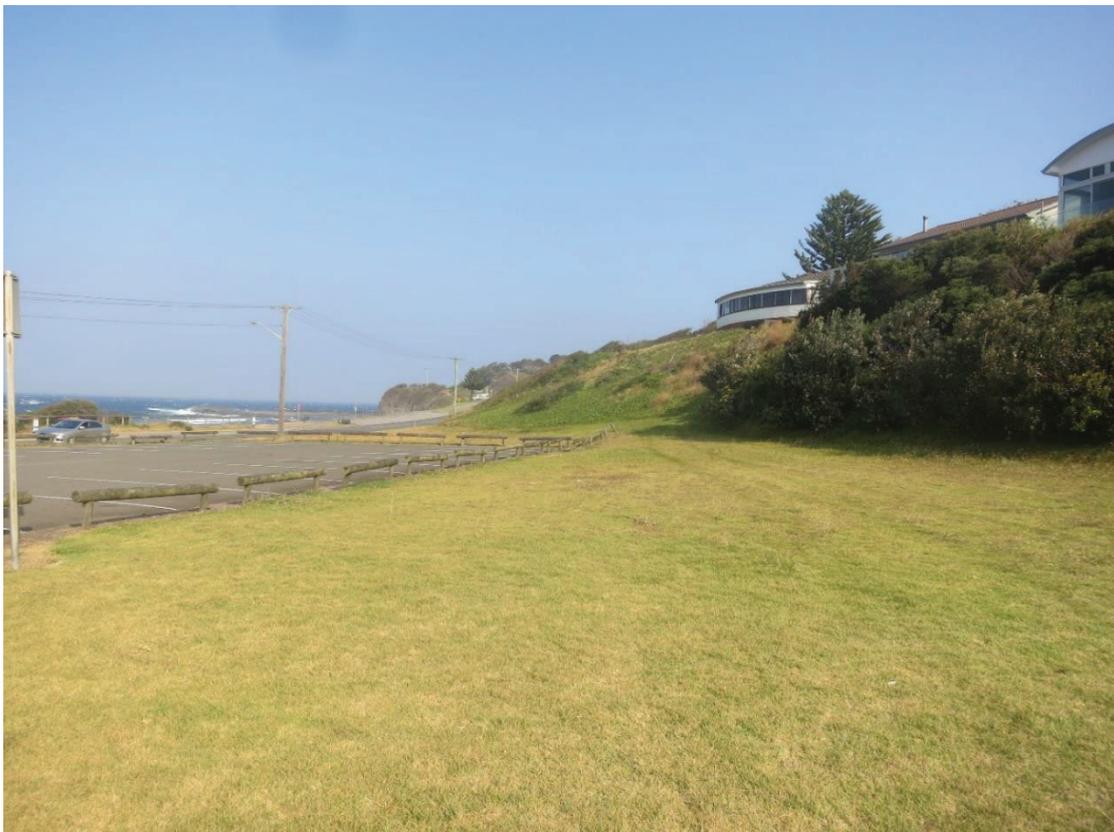
Geering St foreshore houses are located on a bedrock bluff slope. Under a future climate scenario, the toe of this slope may become exposed to wave action. If this occurs, some slope adjustment may occur in the event that highly weathered rock material and/or colluvial deposits become impacted by wave action. However, the geotechnical profile of this bedrock bluff slope is unknown at this stage. It is recommended that a geotechnical assessment be required for new development or extensions proposed where allotment boundaries adjoining the bluff slopes are located adjacent to the coastal hazard zones. Additionally, residents should monitor dwellings for signs of movement (e.g. formation of crack in brick work).

Figure 14 Geering St foreshore properties potentially exposed in the future

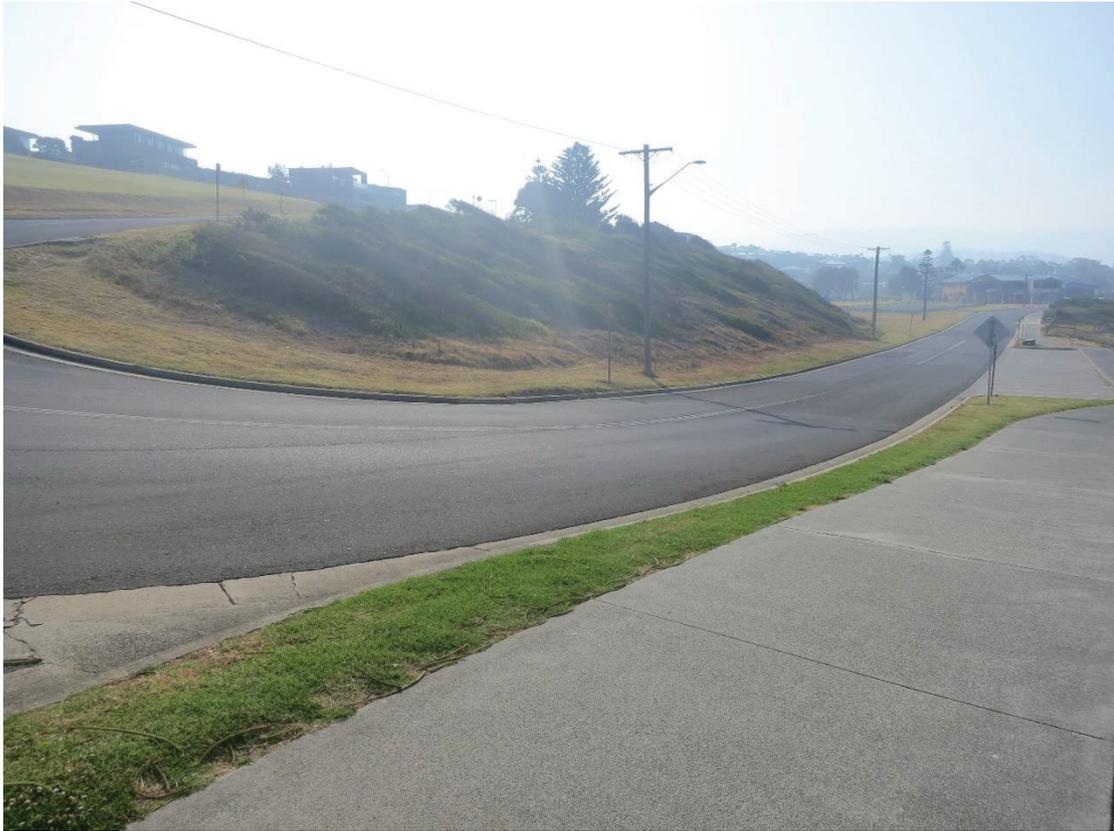
The road, foot path and car park on Pacific Ave is potentially built on the same colluvium sediments as the southern Warri Beach car park and possibly exposed to wave, undercutting and slumping due to storm wave action. However, this area is possibly partially supported by bedrock, but will require further geotechnical investigation to confirm this risk, additionally, this area has been identified in the erosion mapping see Section 3.

Infrastructure and public Assets: Road, foot path and car park on Pacific Ave	<ul style="list-style-type: none"> Infrastructure located on the foreshore is potentially built on the same sediments as the south Werri Beach car park. Additionally, the proximity to wave action indicates possible exposure to undercutting and slumping by wave action. Area is possibly partially supported by bedrock, but may require further geotechnical investigation to confirm risk. Erosion risk has been identified in erosion mapping see Section 3 Coastal Erosion and Shoreline Recession
Recommendation	
South Werri Beach Car park	<ul style="list-style-type: none"> Monitor erosion of adjacent shoreline. If shoreline erosion occurs and threatens the car park asset, a more detailed geotechnical assessment may be warranted to determine the erosion susceptibility of the car park.

Figure 15 Pacific Ave, foot path and car park potentially exposed to undercutting and slumping by wave action in the future

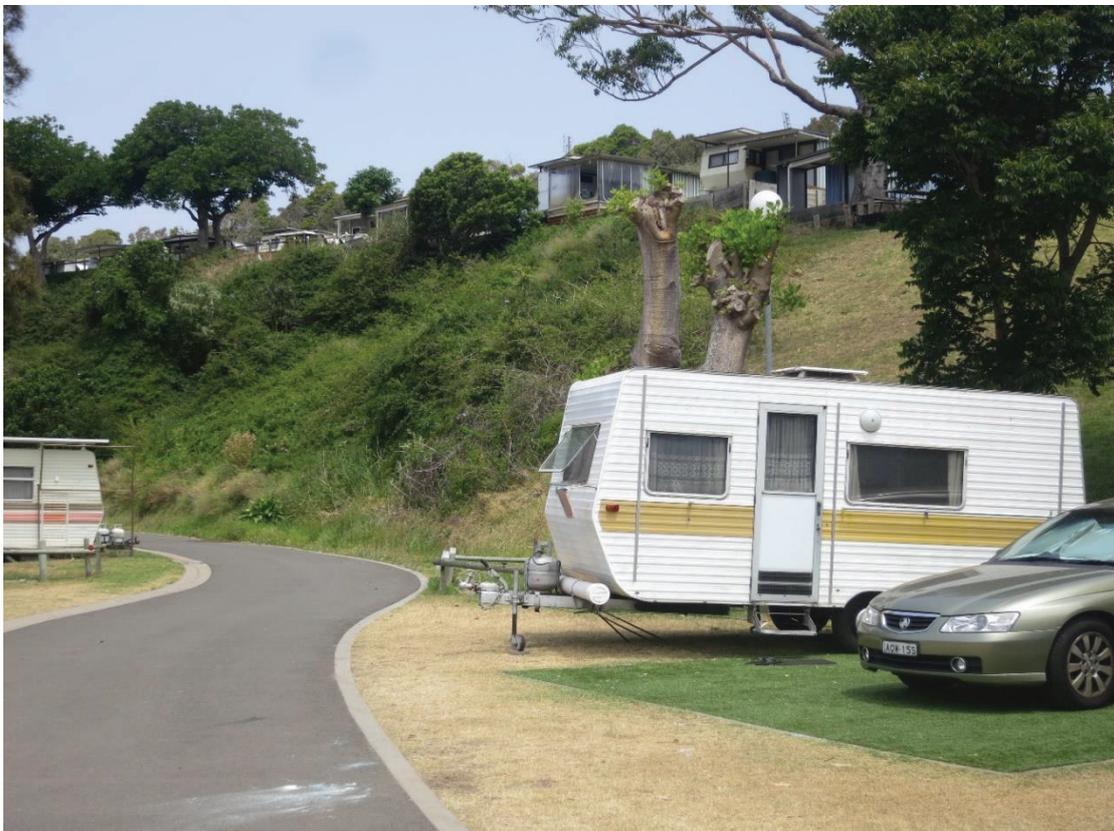
No exposure- stable sloping profile with private assets set back from the coast. The only Big4 asset identified to have a potential exposure appears to be built on bedrock.

Figure 21 Big4 assets built on suspected bedrock

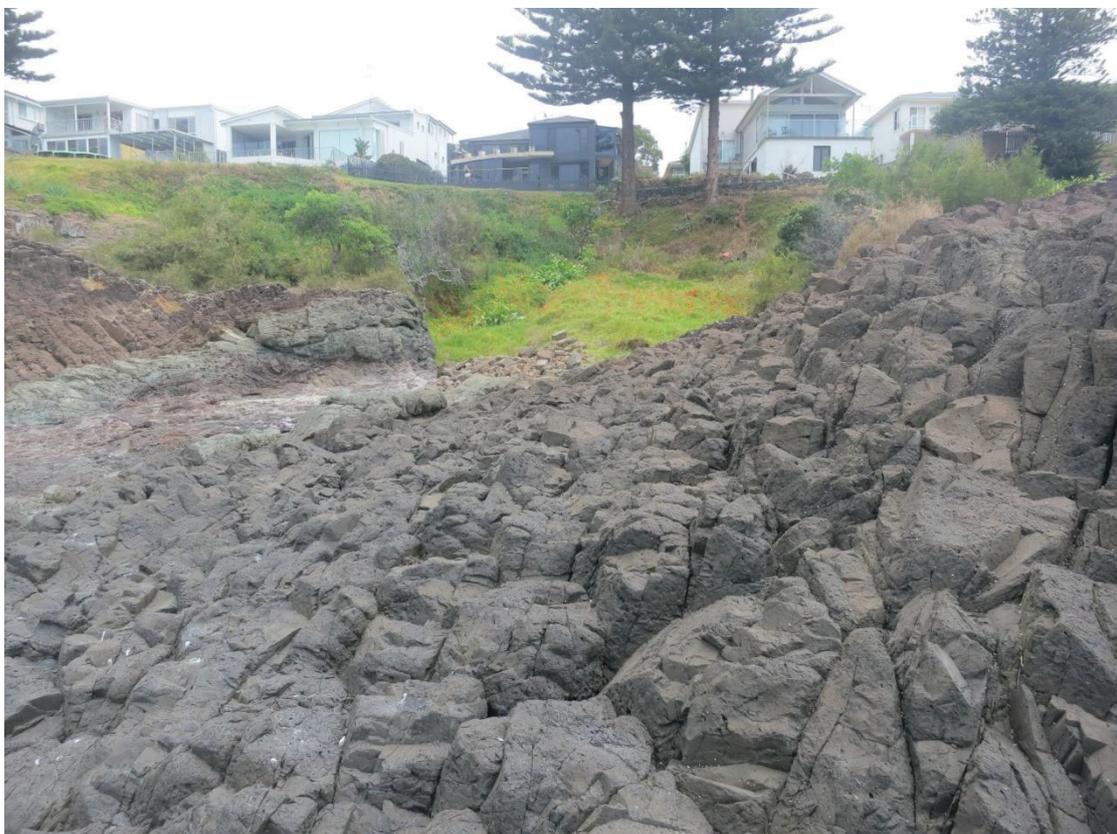
Residential properties on Boanyo Ave are located landward of a volcanic lava tube. The geological material underlying allotments adjacent to the exposed volcanic lava tube on the rocky shoreline is unknown. The underlying material may be unconsolidated sediments, consistent with exposures seaward of the property boundaries. If located on sediments/colluvium, these residential lots may be potentially exposed to hillslope process and associated geotechnical instability. Rock rubble fill placed seaward of properties suggest some instability has occurred in the past. A geotechnical assessment should be required for new development or extensions proposed within this area, particularly where allotment boundaries are near the cliff line. Additionally, residents should monitor dwellings for signs of movement (e.g. formation of crack in brick work).

Figure 23 Potentially exposed property on Boanyo Ave behind radial lave tube

Geotechnical Summary Recommendation	
Residential Assets: Boanyo Ave	<ul style="list-style-type: none"> • Require a geotechnical assessment for new development or extensions proposed at 24 and 26 Boanyo Ave, where allotment boundaries are in close proximity to cliff line. • Residents can monitor dwellings for signs of movement (e.g. formation of crack in brick work)
Residential Assets: Boanyo Ave	<ul style="list-style-type: none"> • Require a geotechnical assessment for new development or extensions proposed at 2 and 4 Boanyo Ave, where allotment boundaries are in close proximity to cliff line. • Residents can monitor dwellings for signs of movement (e.g. formation of crack in brick work)
Residential Assets: Gwinganna Ave	<ul style="list-style-type: none"> • Require a geotechnical assessment for new development or extensions proposed at 4 Gwinganna Ave, where allotment boundaries are in close proximity to cliff line. • Residents can monitor dwellings for signs of movement (e.g. formation of crack in brick work) • Landowner may consider redirecting stormwater outflows away from vertical cliff face

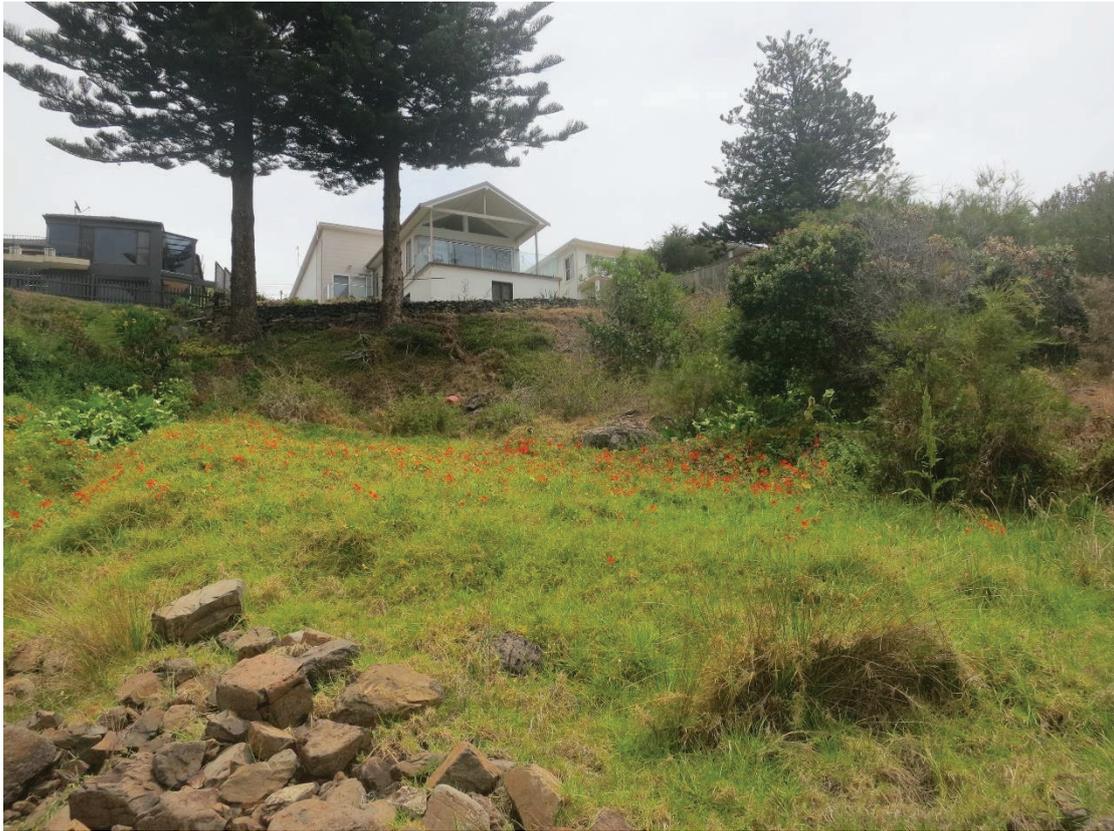
Figure 24 Foreshore dwelling looks to be located on a localised occurrence of unconsolidated sediment (or anthropogenic fill?) that infill a volcanic lava tube on Boanyo Ave

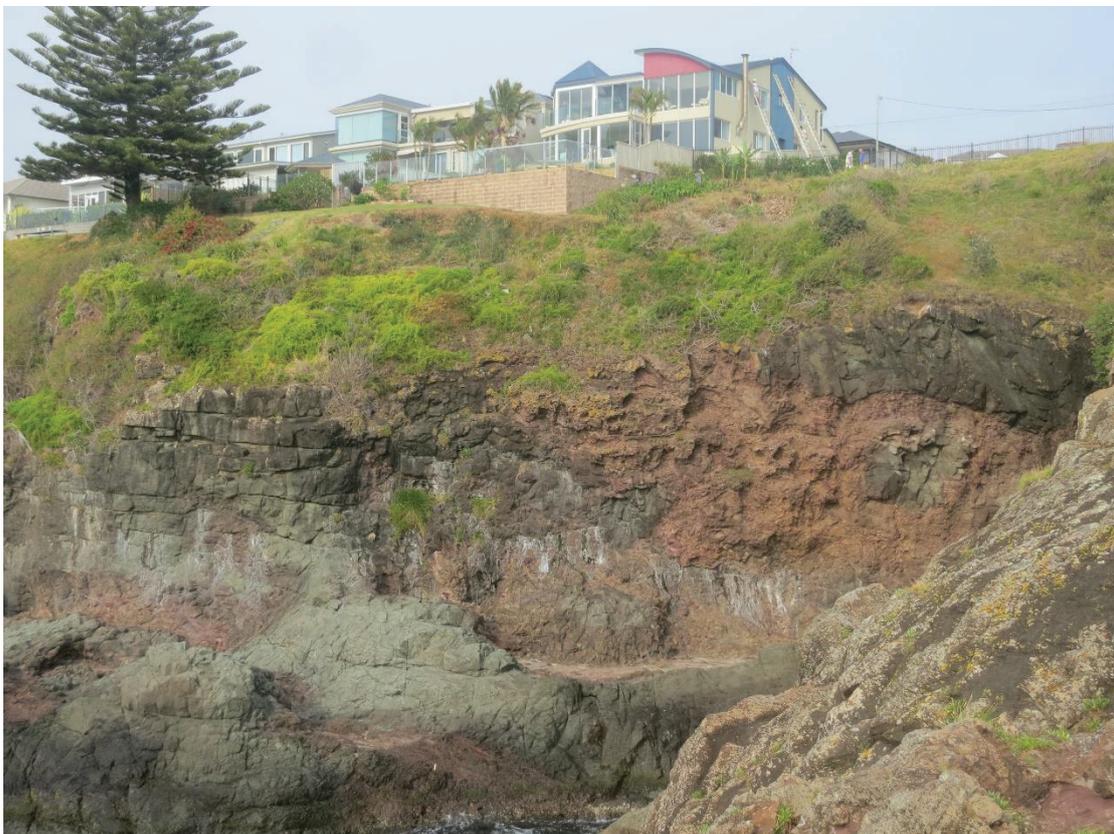
Some residential properties along Boanyo Ave are in close proximity to an undercut cliff and cave profile, the cliff face shows erosion from weathering and fracturing of cliff face profile. Future erosion of the cliff face profile will potentially expose the properties built above the cave. A geotechnical assessment should be required for new development or extensions proposed along Boanyo Ave, particularly where allotment boundaries are close to the cliff line. Additionally, residents can monitor dwellings for signs of movement (e.g. formation of crack in brick work).

Figure 25 Properties on Boanyo Ave built on cliff face are potentially exposed (southern side of cave)

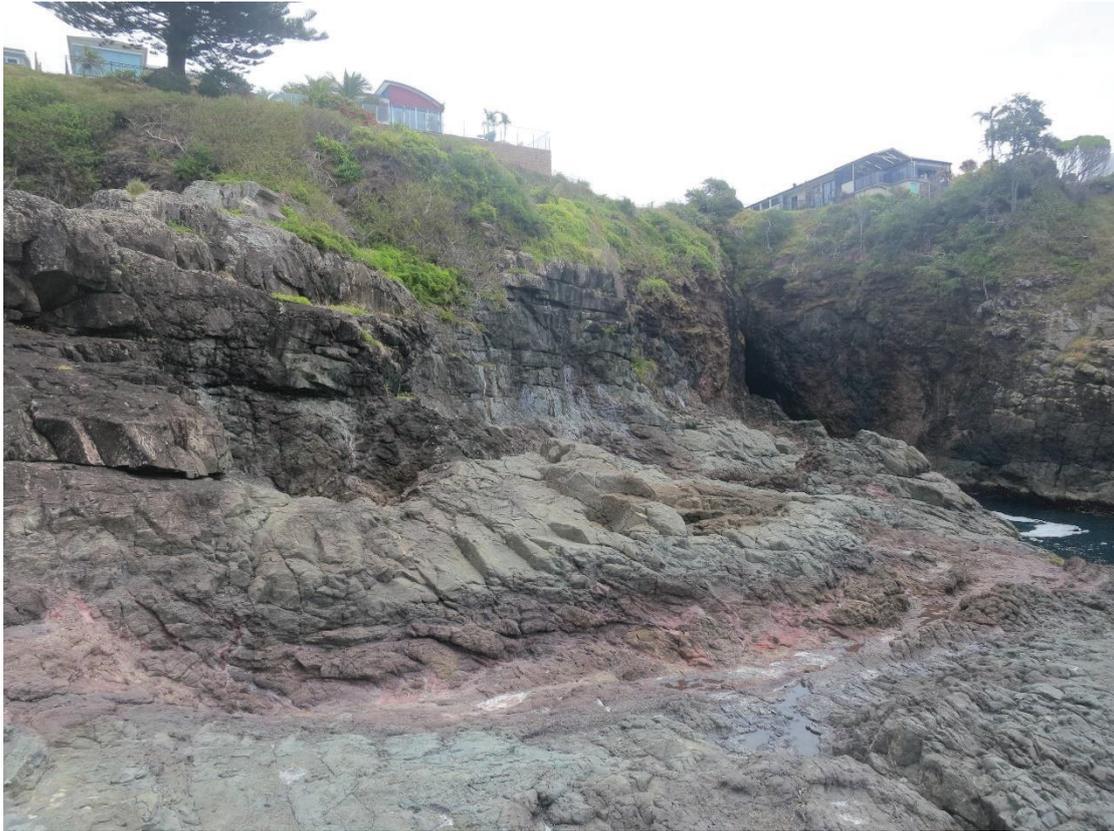
Figure 26 Properties on Boanyo Ave built on cliff face, in close proximity to a vertical cave are potentially exposed (northern side of cave)

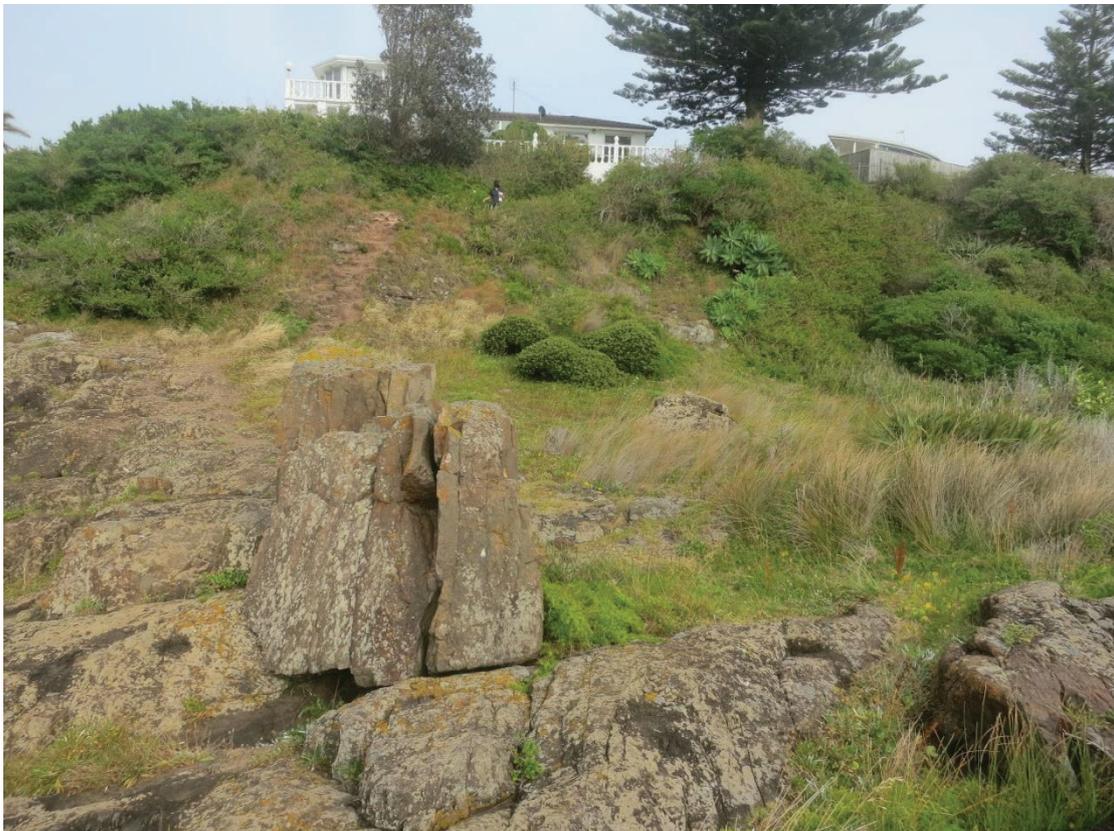
A large block fall was observed down slope of a cliff side house on Gwinganna Ave, on the southern side of Kaleula Head. Additionally, a stormwater pipe discharging from the property down slope of the house was observed. A geotechnical assessment should be required for new development or extensions proposed at this property and the landowner may consider redirecting stormwater outflows away from vertical cliff face. Additionally, residents should monitor dwellings for signs of movement (e.g. formation of crack in brick work).

Residential Assets: Gwinganna Ave	<p>Residential property on 4 Gwinganna Ave at the southern side of Kaleula Head (Figure 27)</p> <ul style="list-style-type: none"> Large block fall observed down slope of cliff side house (Figure 27) Stormwater flow from property discharged down slope of house (Figure 28). Stormwater discharge can promote hillslope processes and therefore increasing exposure to adjacent properties.

Figure 27 Residential properties on Gwinganna Ave at the southern side of Kaleula Head showing mega blocks fallen down slope of houses

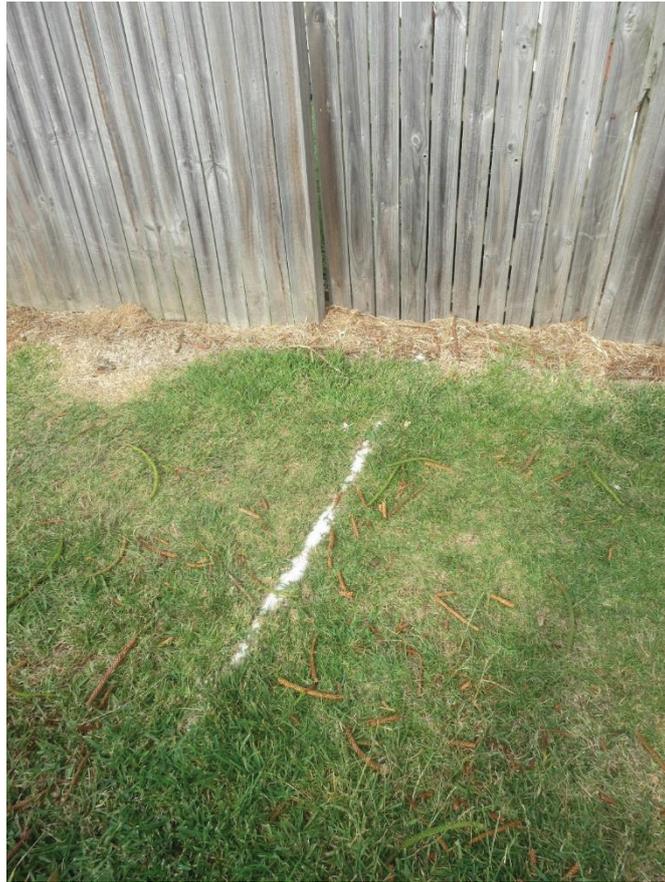
Figure 28 Drainage pipe from property on Gwinganna Ave at the southern side of Kaleula Head discharging over headland

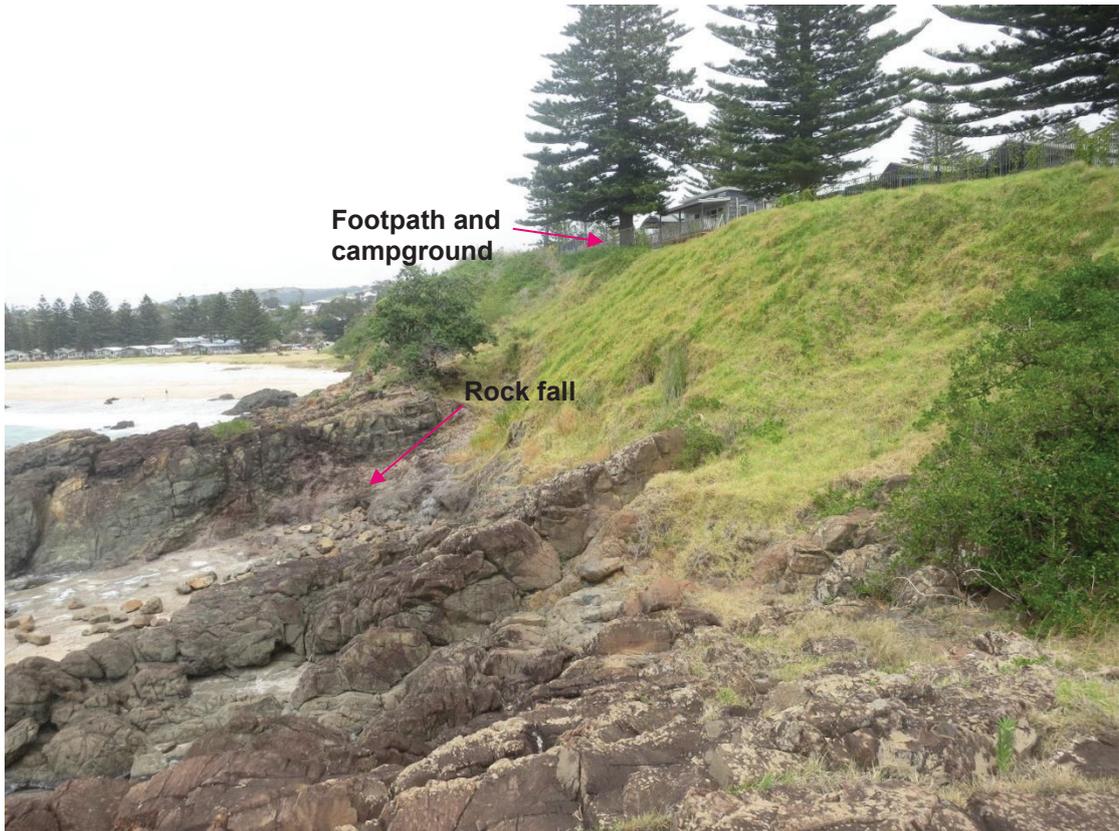
Some localised rockfall and undercutting was observed at Kendalls Point. The steep slope may adjust in the future which could potentially expose the footpath and campground pool. It is recommended that the cliff top pathway be monitored for evidence of slope movement (e.g. cracking), a site specific geotechnical assessment is warranted, if this occurs.

Figure 30 Kendalls Point footpath and localised rock fall

Geotechnical Summary	
Private & public Assets: Campground pool & footpath	<ul style="list-style-type: none"> • Monitor cliff top pathway for evidence of slope movement (e.g. cracking). A site specific geotechnical assessment is warranted, if this occurs
Public Assets: Showground and shared footpath	<ul style="list-style-type: none"> • As above

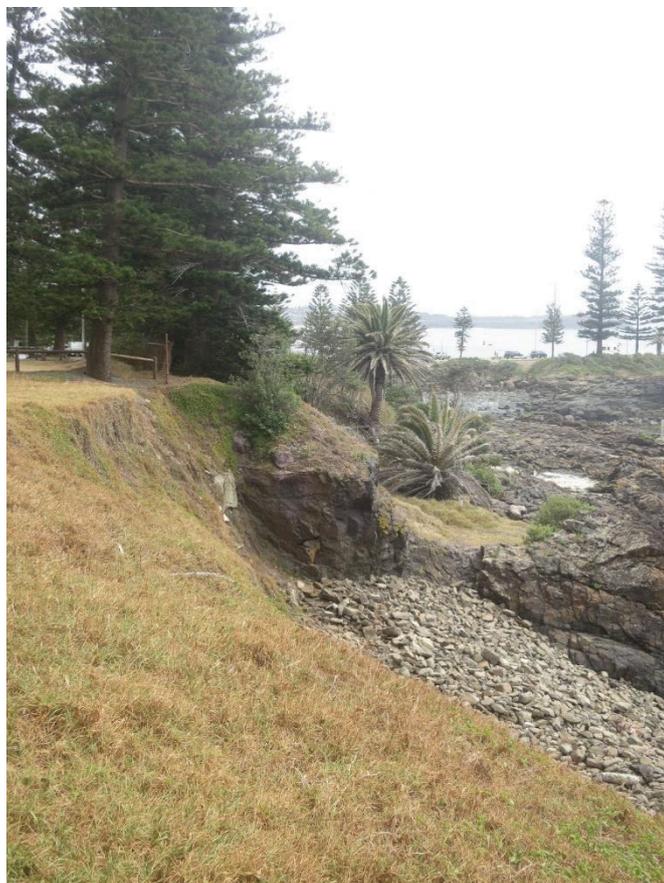
Figure 31 Over steepened slope showing evidence of movement

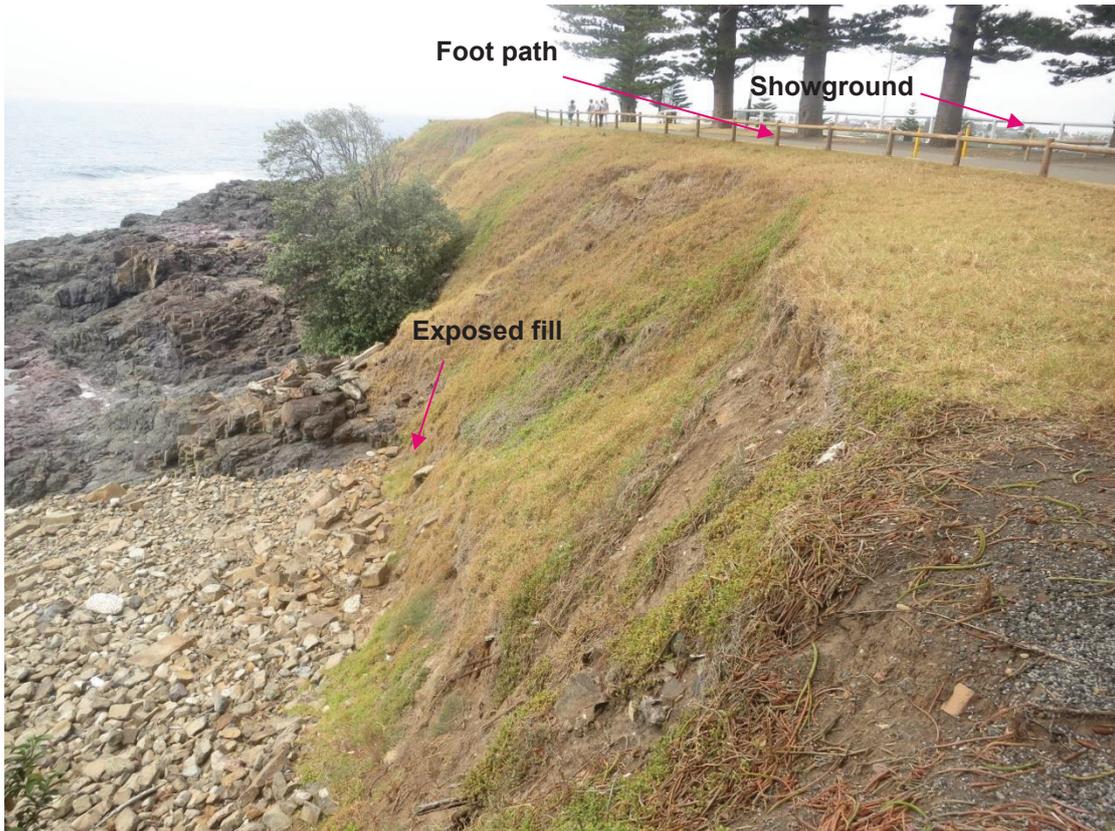
At the showground and shared footpath on Church Point, evidence of slope movement exposing fill in places was observed, particularly where slope stabilisation works were absent. Recreational assets are at risk if slope continues to move in areas with over steepened slope profile (e.g. northern side of Church Point) and slope adjustment may expose sections of shared footpath and edges of the showground to geotechnical instability. Additionally, cracking of the shared footpath was observed on the southern side of Church point indicates slope movement. It is recommended that the cliff top pathway be further monitored for evidence of slope movement (e.g. cracking), a site specific geotechnical assessment is warranted, if this occurs.

Figure 32 Exposed fill at the northern side of Church Point
