Appendix D Cliff and Slope Instability Walkover Field Survey

From:	Madelaine Broadfoot, Paul Donaldson	To:	Kiama CMP Team
Date:	22 November 2019	CC:	Byron Robinson
Subject:	Geomorphological Walkover Field Survey and Preliminary Cliff/Slope Instability Exposure Assessment: Kiama's Rocky Coastline

1.1 Overview

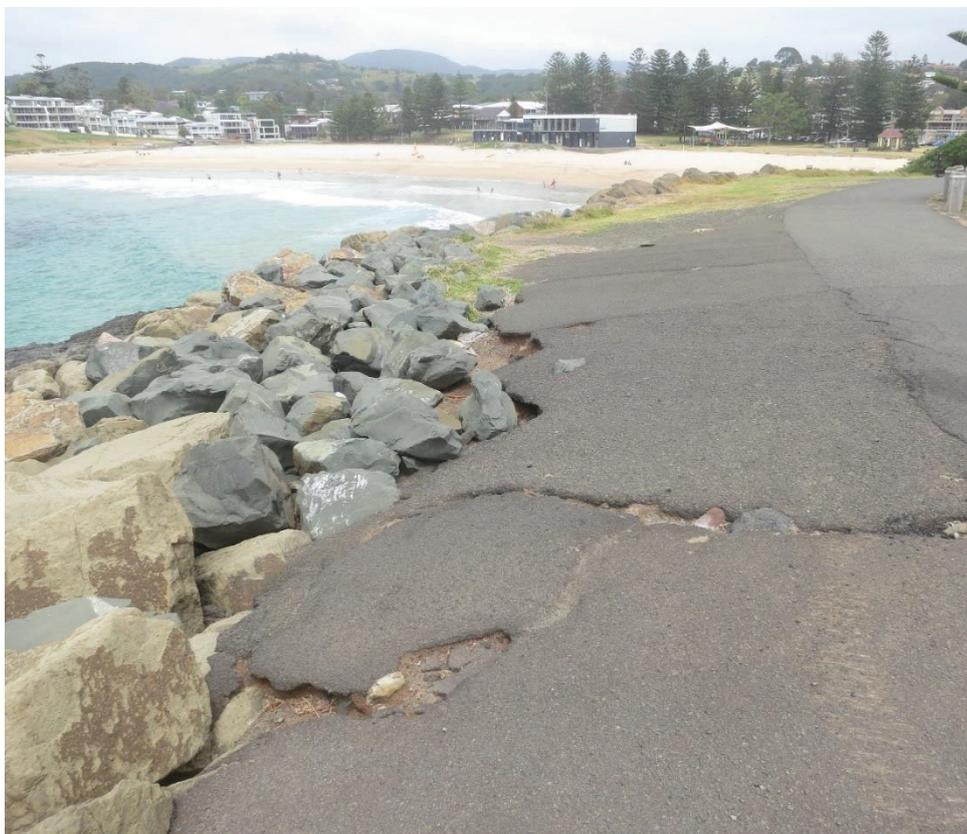
Geomorphology	<ul style="list-style-type: none"> Steep fill slope Fill exposed at showground Over steepened slopes Sloping rock platform
Coastal Cliff / Slope Processes	<ul style="list-style-type: none"> Localised rock falls Hill slope processes Marine processes
Asset Exposure Summary	
Overview: Coastal Fringing Assets	<ul style="list-style-type: none"> Private Assets Public Assets
Private & Public Assets: Campground pool & footpath	<p>Campground and footpath on Kendall Point (Figure 30)</p> <ul style="list-style-type: none"> Some localised rockfall (Figure 30) and undercutting occurring at Kendalls Point The steep slope may adjust in the future which could potentially expose the footpath and campground pool.
Public Assets: Showground and shared footpath	<p>Kiama showground and shared footpath on Church Point</p> <ul style="list-style-type: none"> Evidence of slope movement exposing fill in places, where slope stabilisation works are absent (Figure 31) Recreational assets are at risk if slope continues to move in areas with over steepened slope profile (e.g. northern side of Church Point) (Figure 31). Slope adjustment may expose sections of shared footpath and edges of the showground to geotechnical instability (Figure 32) Stable rocky slope below areas of fill may provide protection from marine processes in most instances Observed cracking of the shared foot path on the southern side of Church point indicates slope movement (Figure 33)

Figure 33 Cracking of shared footpath at the southern side of Church Point

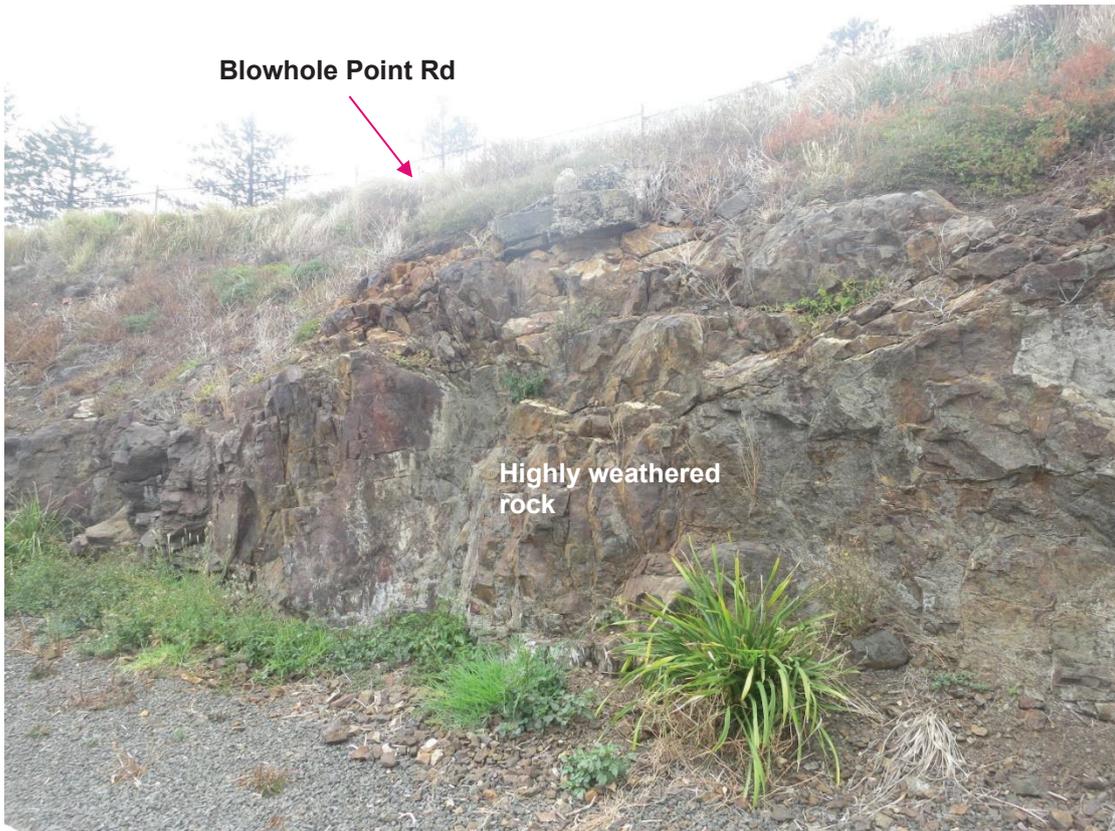
On the NW side of the Blowhole, approx.120 m length of the Blowhole Point Rd, located immediately upslope of Stobo Rd, is situated on a highly weathered bedrock material. Evidence of minor rock falls was observed. The weathered vertical bedrock profile and proximity to wave action increases the roads exposure to slope instability. It is recommended that the cliff face be monitored for potential rock falls and slope movement and a site specific geotechnical assessment is warranted, if this occurs.

Figure 34 Highly weathered rock below Blowhole Point Rd

Recommendation	
Infrastructure: Blow Hole Point Rd	<ul style="list-style-type: none"> Monitor vertical cliff face for potential rock falls and slope movement A site specific geotechnical assessment is warranted, if this occurs
Infrastructure: Harbour wall	<ul style="list-style-type: none"> Undertake a coastal engineering condition assessment

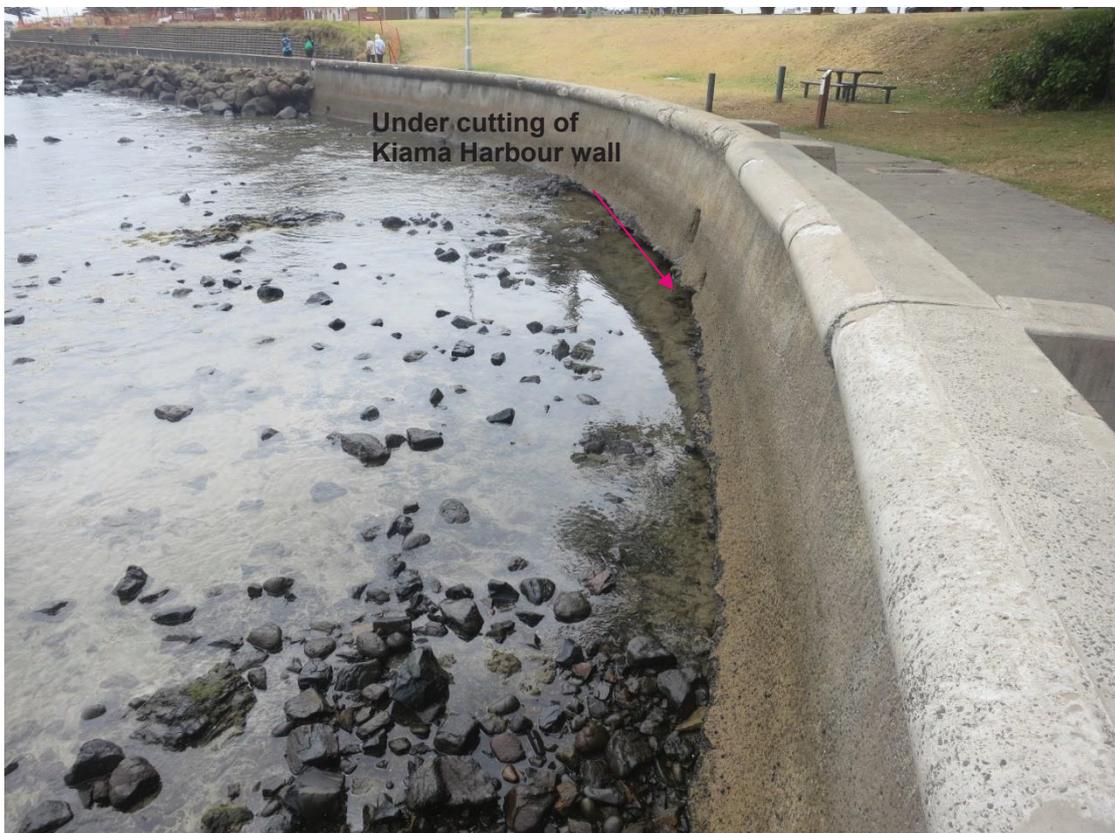
Undercutting of the Harbour seawall towards the SE was observed, it is recommended that a structural condition assessment be undertaken.

Figure 35 Undercutting of harbour wall by marine processes

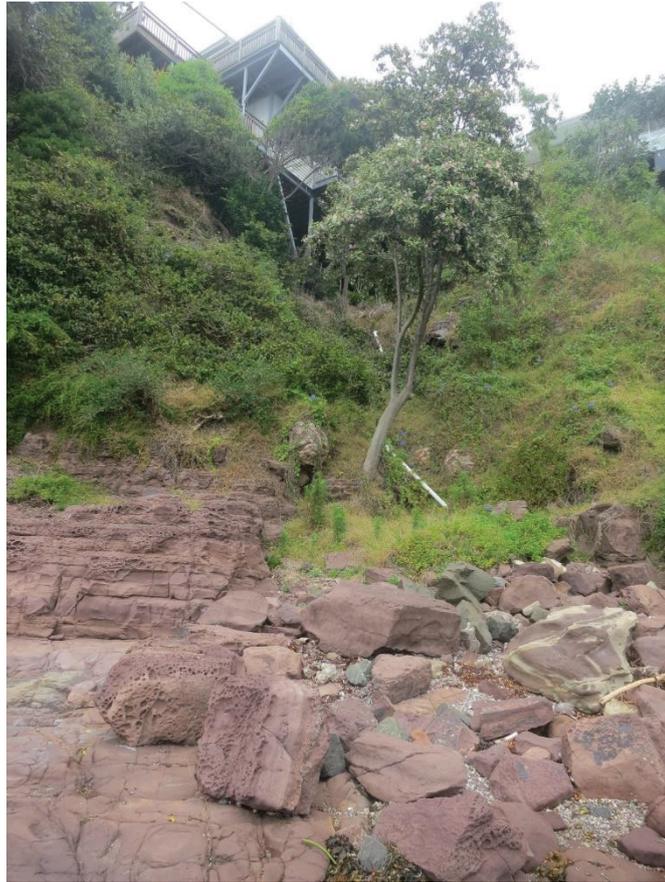
Properties located on and adjacent to the cliff face are exposed to cliff instability hazards. The thinly bedded sandstone exposed in the cliff face is relatively active, compared to the other sections of the Kiama coast. Houses cantilevered over the top of the actively eroding cliff face are highly exposed to geotechnical instability and increased exposure to undercutting where wave run up can reach active cliff face. A geotechnical assessment should be required for new development or extensions proposed along Pheasant Point Dr, where allotment boundaries are in close proximity and/or extend over the active cliff line. The residents should monitor dwellings for signs of movement (e.g. formation of crack in brick work). Additionally, council should monitor cliff stability down slope of cliff side residential properties.

Figure 36 House cantilevered over cliff face with evidence of rock falls

Recommendation	
Residential Assets: Houses, Pheasant Point Dr	<ul style="list-style-type: none"> A Geotechnical assessment is required for new development or extensions proposed along Pheasant Point Dr, where allotment boundaries are in close proximity and/or extend over the active cliff line. Residents to monitor dwellings for signs of movement (e.g. formation of crack in brick work). Council to monitor cliff stability down slope of cliff side residential properties.
Infrastructure & Public Assets:	<ul style="list-style-type: none"> Maintain safety fencing and signage along areas with high rock fall activity

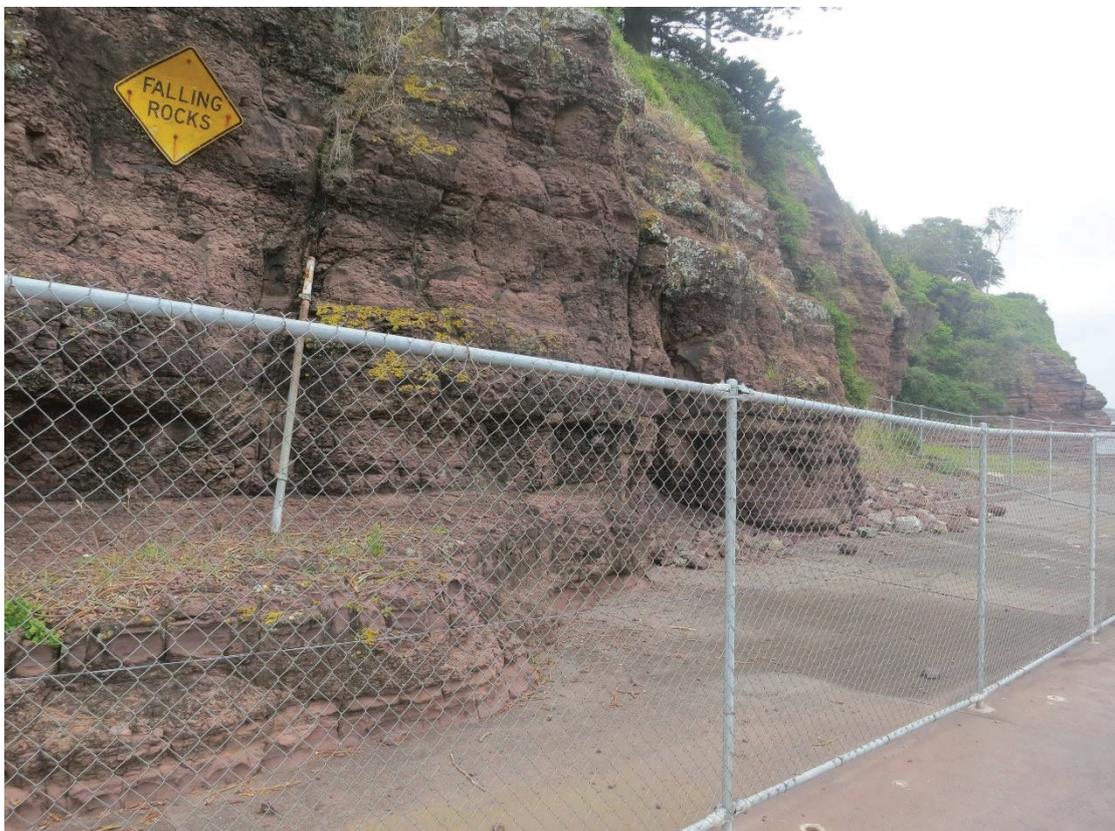
Figure 37 Pheasant Point actively eroding cliff face

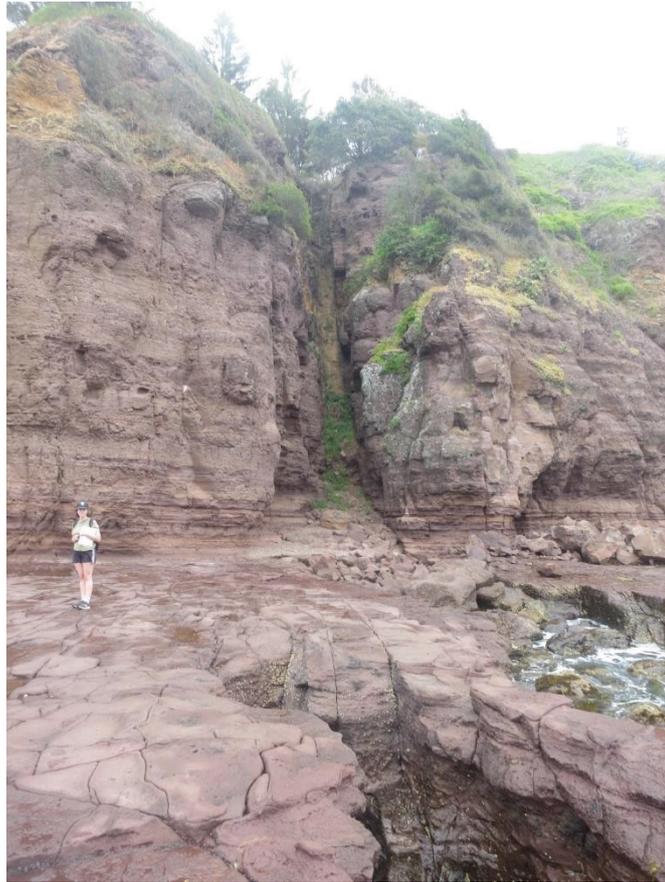
Figure 38 Igneous dyke weathered below rock platform and into cliff face

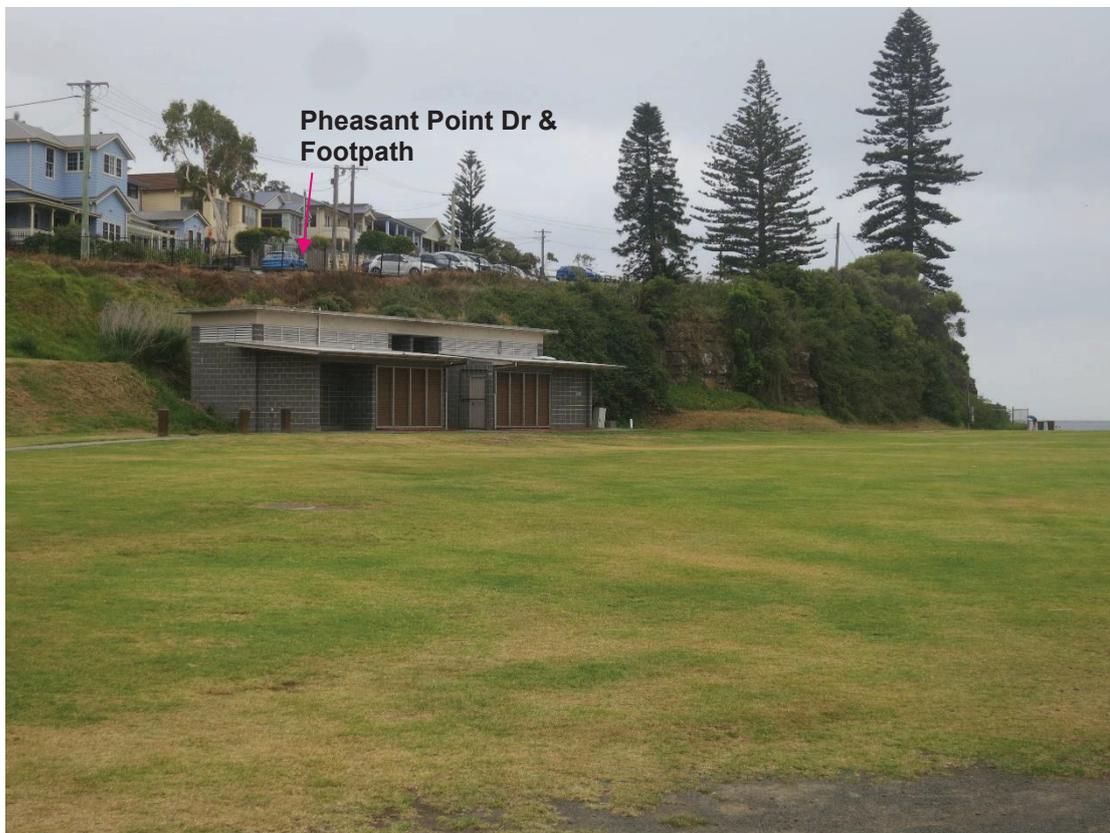
Pheasant Point Dr footpath located adjacent to the cliff face, spanning Black Beach Reserve toilet block to the Continental Pool ocean baths footpath is set above an actively eroding cliff face. In some sections a safety fence has been set up at the bottom of the cliff due to public safety risk of rock falls.

Figure 39 Pheasant Point Dr and footpath

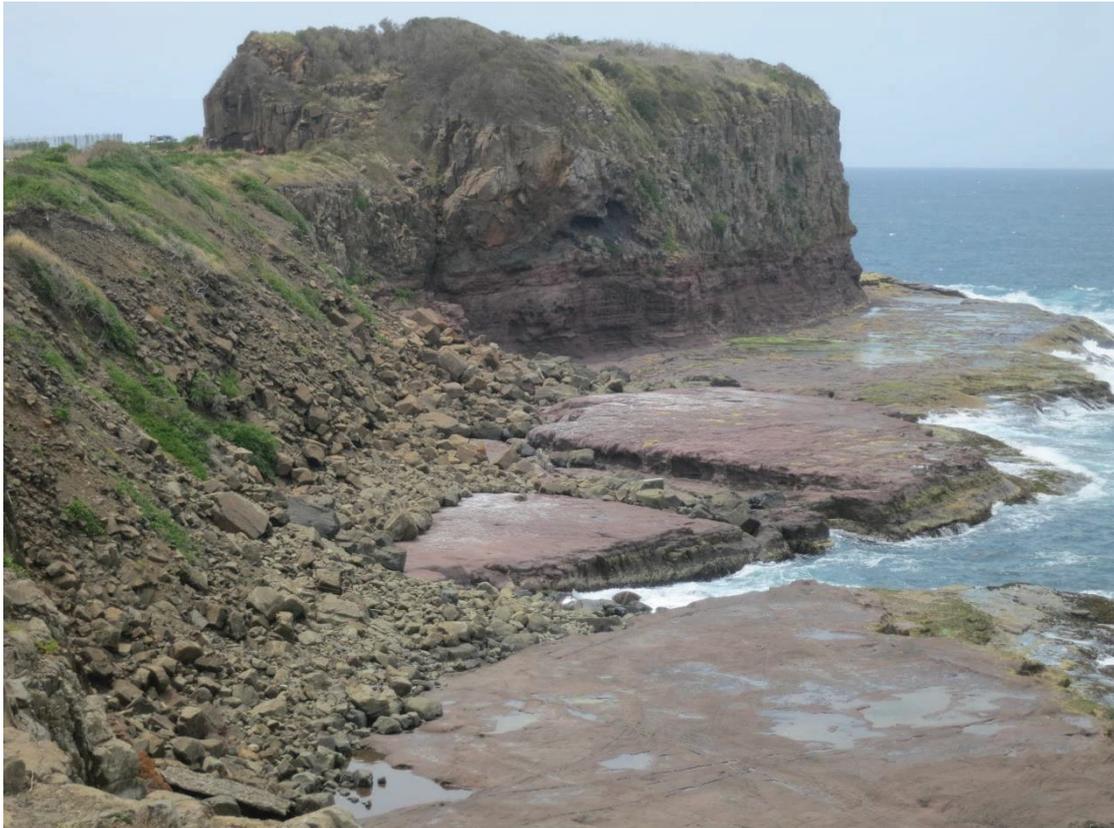
The southern side of Bombo Headland has an actively eroding cliff face. While no assets are in proximity to the eroding cliff face, there is a potential safety risk, however drainage upgrades and safety fencing have reduced this risk.

Figure 40 Bombo Headland, southern side actively eroding

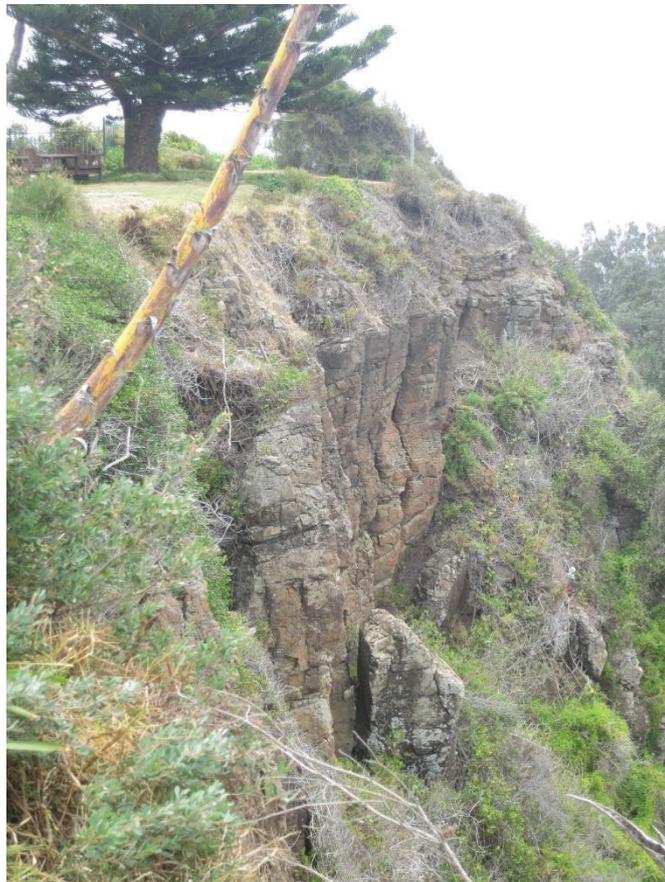
Figure 43 Vertical cliff face failing due to hill slope processes

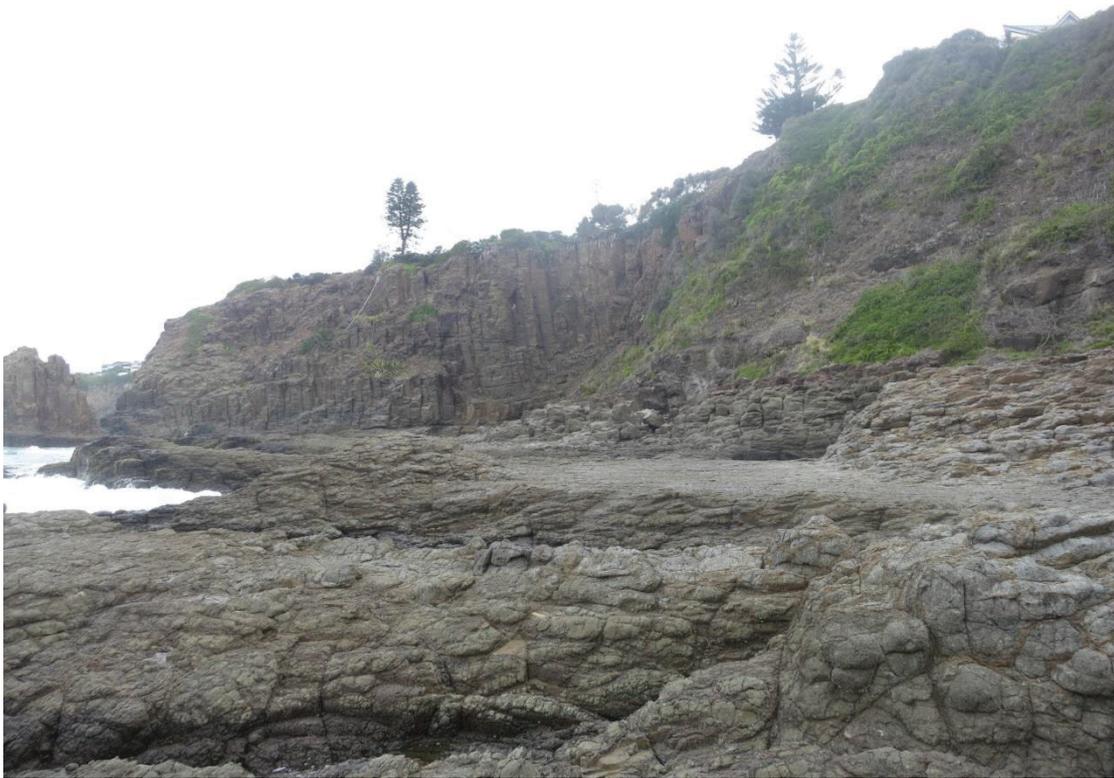
The cliff top of Cathedral Rocks is developed with residential properties. The cliff face on the south side of Cathedral Rocks is vertical and highly jointed, with residential properties are set back from the cliff face by some ~10 metres in this location. The rocky coast on the northern side of Cathedral rocks is steeply sloping, the north facing slopes may have instability as the cliff face adjusts towards a more stable slope that is consistent with the jointing. Residents should monitor dwellings for signs of movement (e.g. formation of

Figure 44 Highly jointed vertical cliff face on the southern side of Cathedral Rocks

Recommendation	
Residential Asset: Houses, Cliff Dr	<ul style="list-style-type: none"> Residents can monitor dwellings for signs of movement (e.g. formation of crack in brick work) Require a geotechnical assessment for new development or extensions proposed along Cliff Dr, especially where allotment boundaries are adjacent to the cliff line.

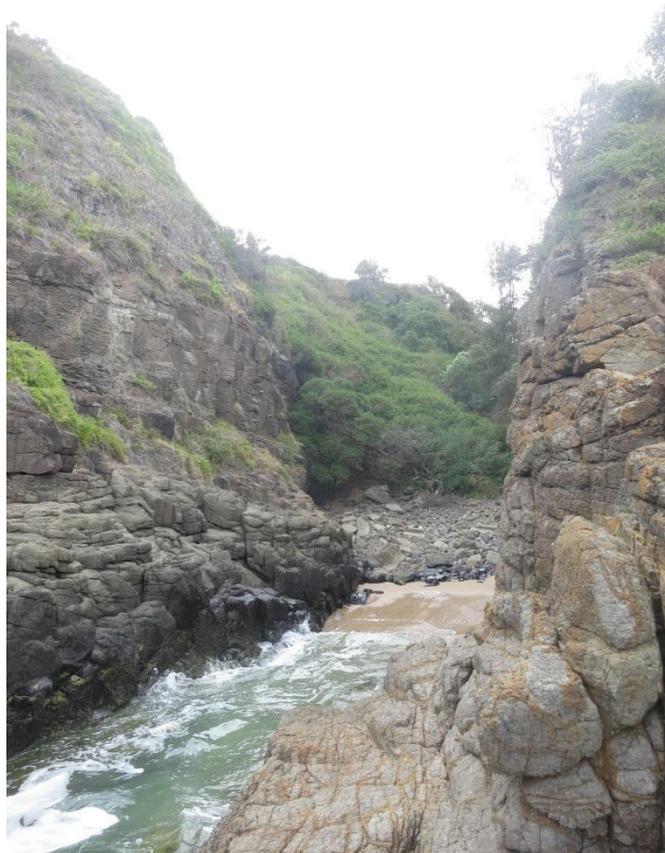
Geomorphology	<ul style="list-style-type: none"> Vertical cliff faces to the south Sloping cliff faces to the north
Coastal Cliff / Slope Processes	<ul style="list-style-type: none"> Hillslope processes
Asset Exposure Summary	
Overview: Coastal Fringing Assets	<ul style="list-style-type: none"> Private assets Residential Assets
Residential Asset: Houses, Cliff Dr	<p>Residential properties above Cathedral Rock section of coastline</p> <ul style="list-style-type: none"> The cliff top of Cathedral Rocks is developed with residential properties. Several properties are in close proximity to the cliff edge (Figure 42). The cliff face on the south side of Cathedral Rocks is vertical and highly jointed (Figure 44). Residential properties are set back from the cliff face by some ~10 metres in this location (i.e. Cliff Drive). The rocky coast on the northern side of Cathedral rocks is steeply sloping. The north facing slopes may have instability as the cliff face adjusts towards a more stable slope that is consistent with the jointing (Figure 45)

Figure 45 Steeply sloping cliff face on the northern side of Cathedral Rocks

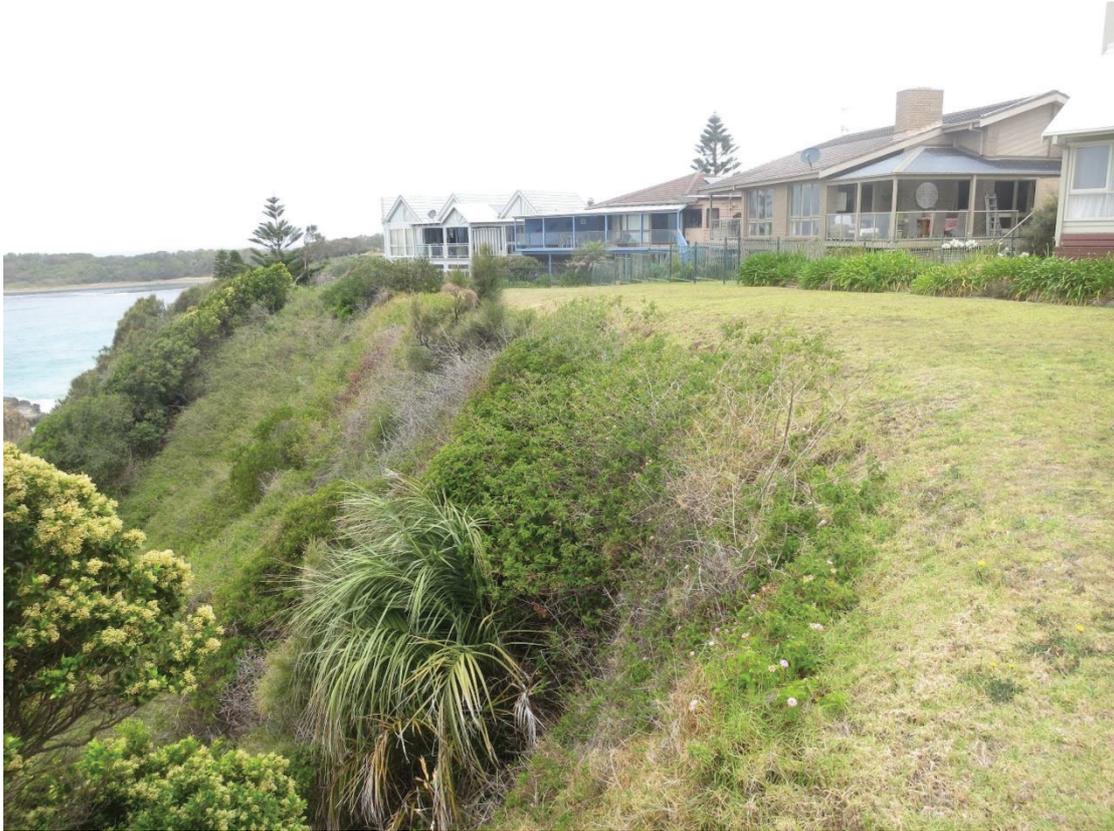
Figure 46 Residential properties on the Cathedral Rock cliff top exposed to potential hazards

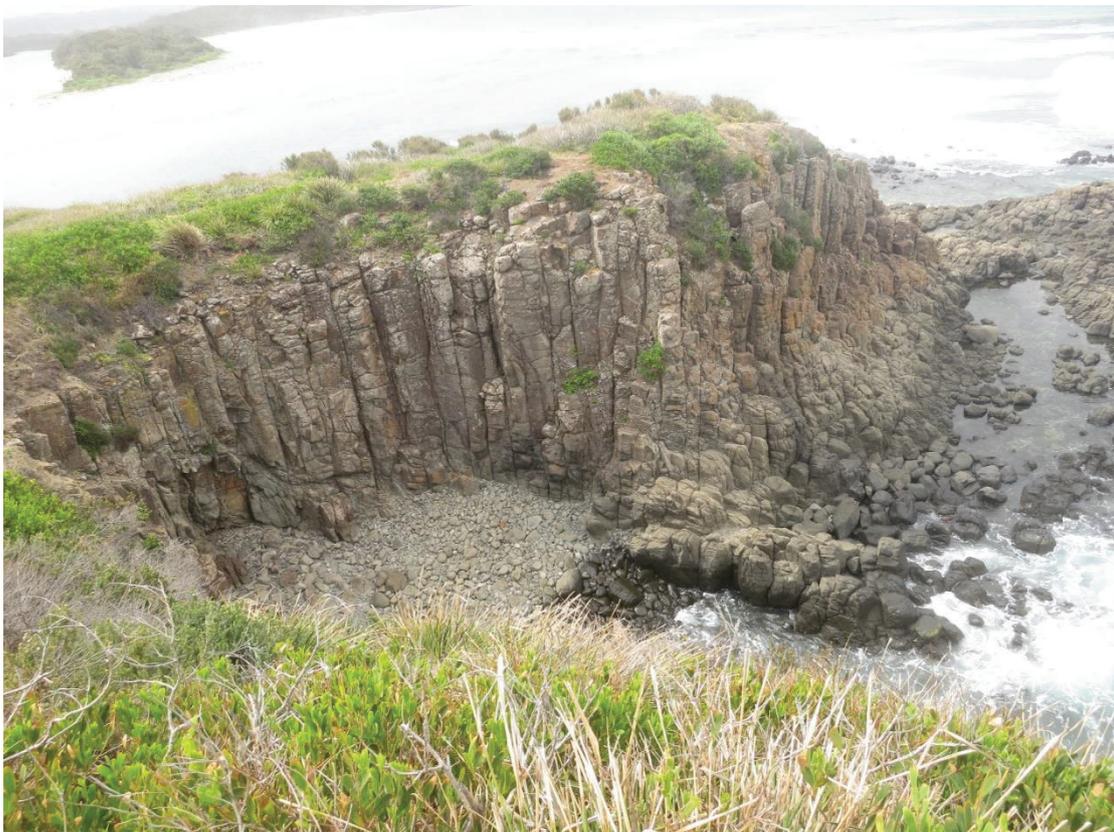
Figure 48 Vertical cliffs and localised rock fall at the eastern edge of Minnamurra point

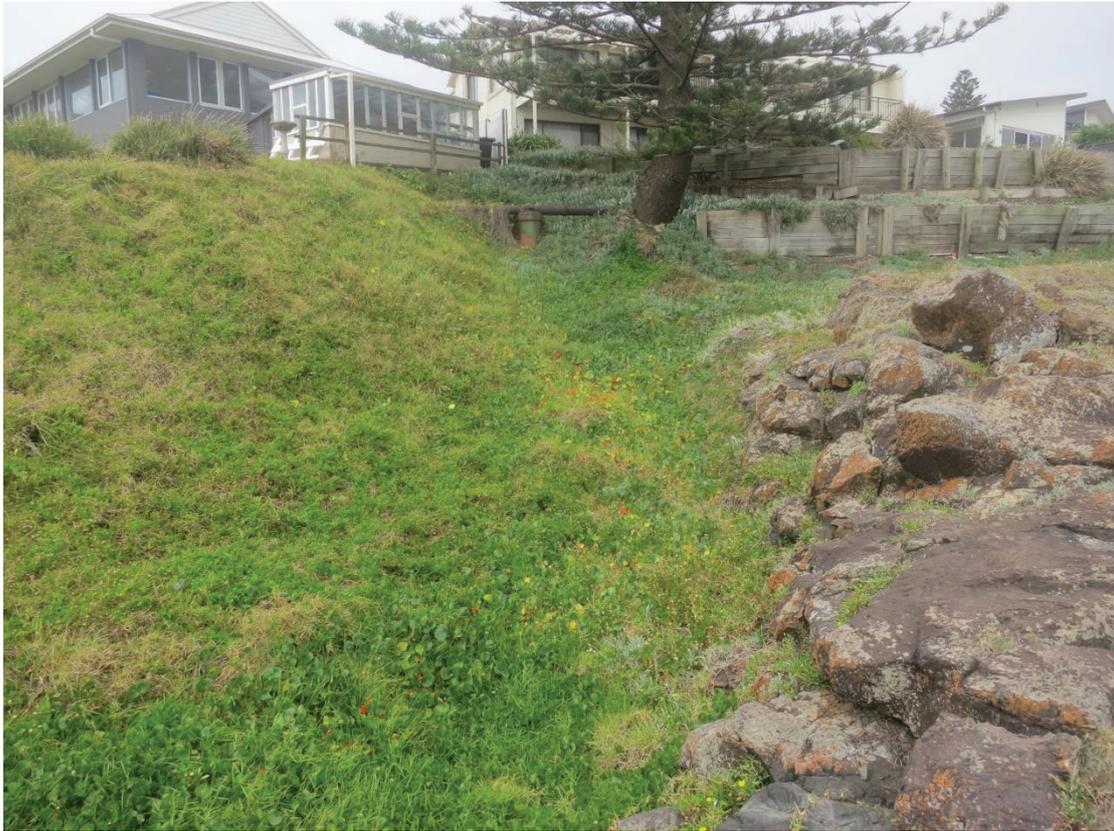
Residential properties on Johnson St, southern side of Minnamurra Point are on low but steeply sloping cliff profiles. Evidence of slope instability was noted, including tree trunk adjustments and defects within built infrastructure. Additionally, observed fracturing of brick and concrete fencing indicates movement of the slope profile. A geotechnical assessment should be required for new development or extensions proposed at this location, particularly where allotment boundaries along Johnston Street are adjacent to the cliff line. Additionally, residents can monitor dwellings for signs of movement (e.g. formation of crack in brick work).

Figure 49 Houses located on steep slope, Johnson St south side of Minnamurra Point

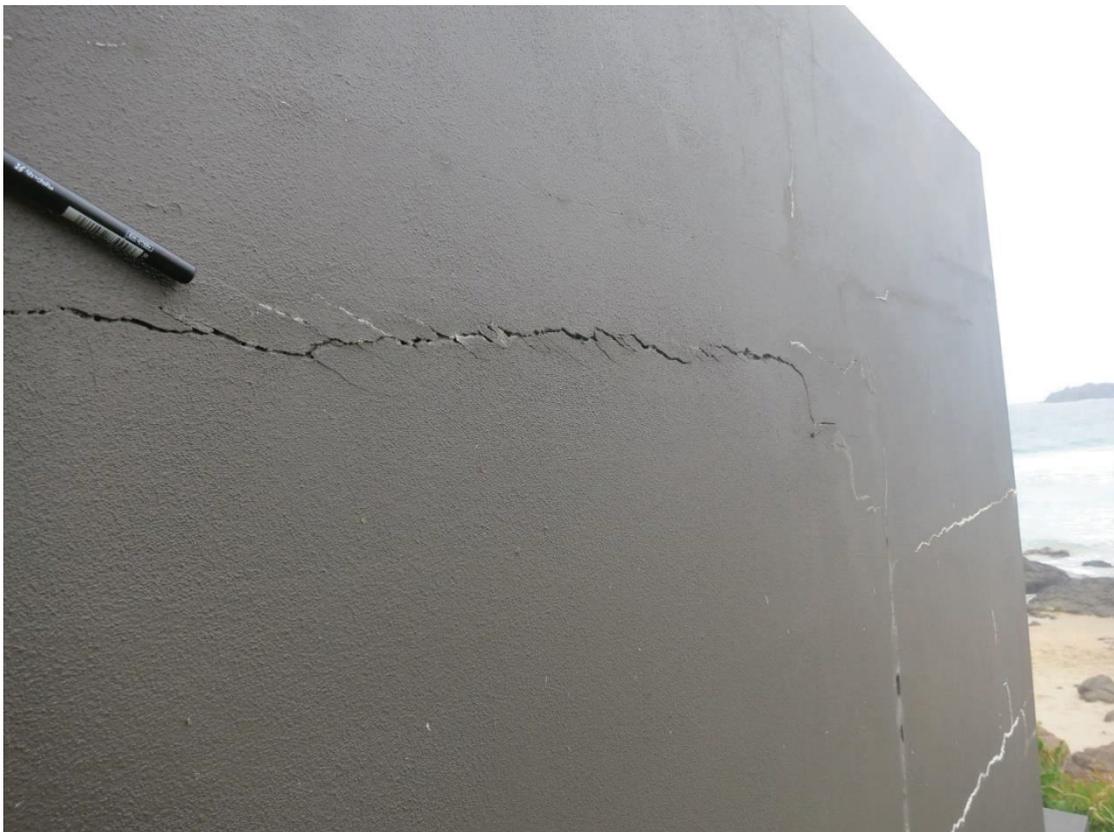
Figure 50 Fracturing of property fences due to instabilities, Johnson St south side of Minnamurra Point

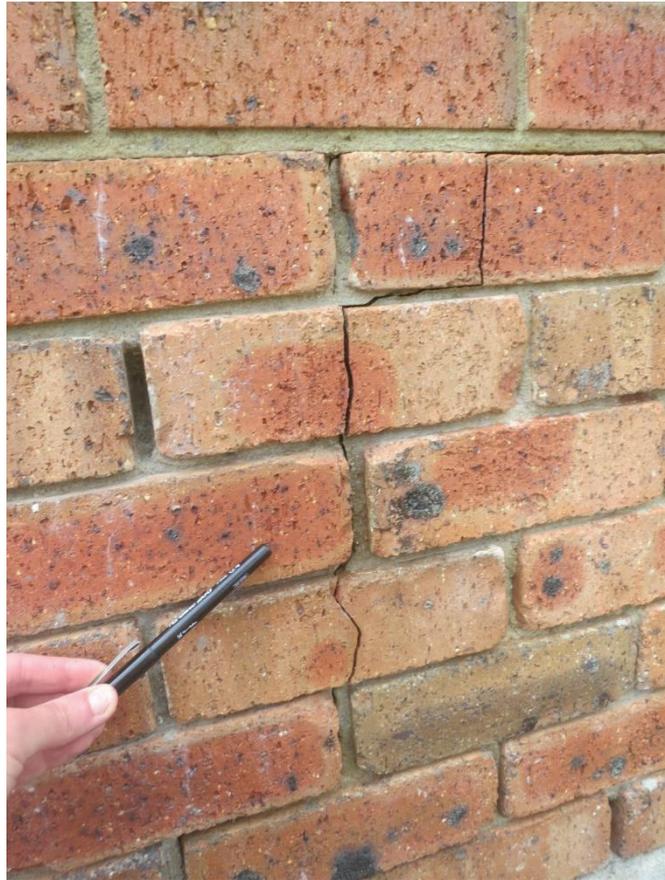
Figure 51 Fracturing of property fences due to instabilities Johnson St south side of Minnamurra Point
