# Minnamurra Rock Wall Assessment

## Concept Design Report

Kiama Municipal Council

311010-00189

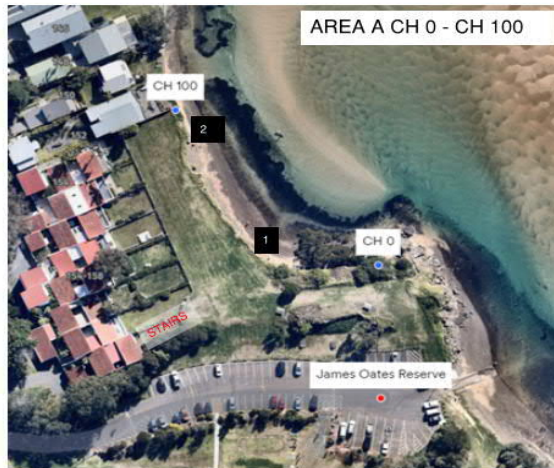
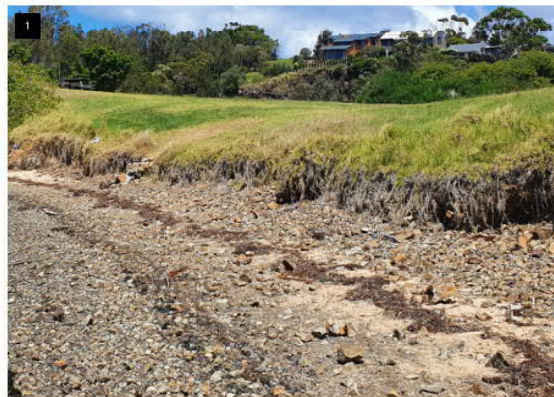
1. Small erosion scarp ~0.5 - 1m high. Add riprap, rock pool or beach nourishment along bank as per concept options provided. Vegetate crest with pig face or similar to sprawl over edge as existing elsewhere. Alternatively, can consider a salt marsh berm in the riprap design. Add formal access point.

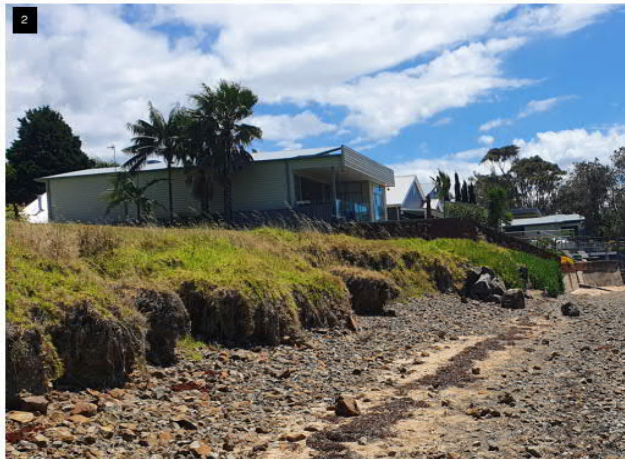
2. Bank erosion, scarp ~1m high. Add riprap, rock pool or beach nourishment along extent of shoreline as per concept options provided. Vegetate crest with pigs face or similar to sprawl over edge as existing elsewhere. Alternatively, can consider a salt marsh berm in the riprap design.

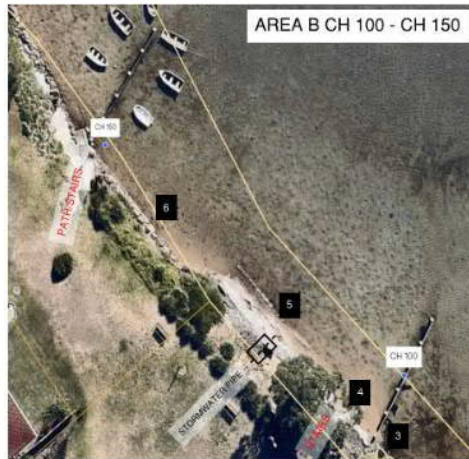
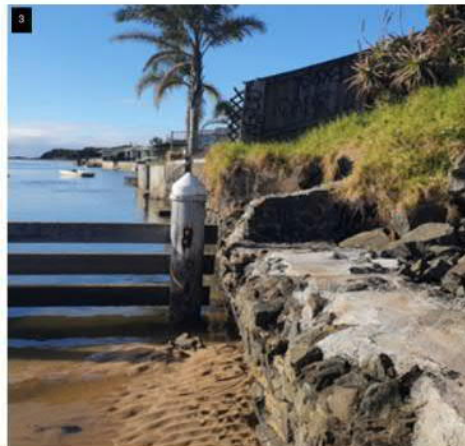
3. Grouted rock wall approximately 1m high. Necking of timber groyne piles - repair with a concrete filler collar (FRP collar that wraps around the pile and filled with appropriate mortar mix) or similar.

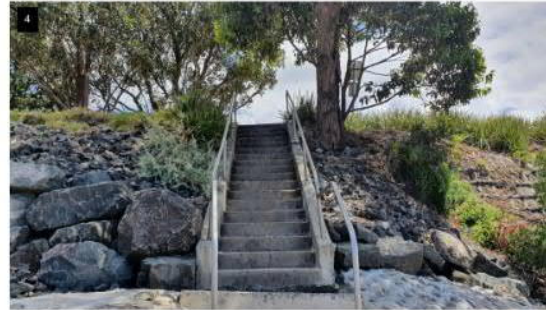
4. Mixture of small rubble and larger rock. Staircase experiencing settlement and cracking. Large gum and light pole at top of stairs. Crest level approximately 3m AHD. Rebuild staircase on stable foundation or on piles. Rebuild revetment (retaining tree as bank stabilisation) with rock rip rap to an adequate scour depth. Vegetate with sprawling pigs face, alternatively a salt marsh berm can be incorporated. Retain light pole and shower if possible, alternatively replace with solar light and move landward.

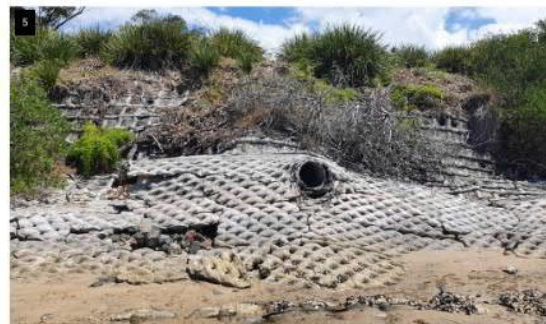
5. Deteriorated concrete storm water pipe with exposed reinforcement. Displaced and cracking concrete mattress. Washout of bank behind mattress. Remove concrete scour matting and construct revetment as in point 4.

| Criteria | Comment | Consequence Category | Rating |
|---|---|---|---|
| Erosion/Condition | Very deteriorated concrete matting<br>Washout behind matting potentially leading to significant slope instability | Major | High |
| Visual Impact | High visual impact, unsightly concrete matting and deterioration of the stormwater pipe | Major | High |
| Safety | Potential safety issues with exposed and deteriorated matting as well as slope instability | Major | High |

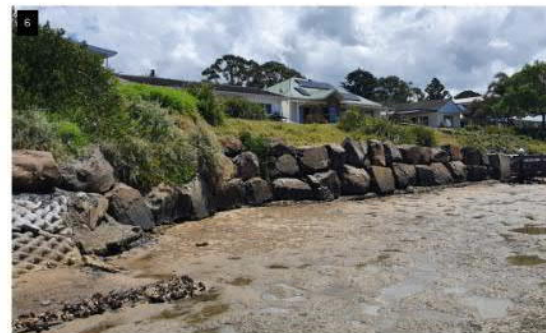
6. Rock wall approximately 2 stones high. Rock diameter approximately 600mm. Areas at the crest of the wall where geotextile is exposed and minor scour however generally in good condition. Stairs at CH150 experiencing settlement of concrete base. Consider incorporating rock scour protection in front of wall, or steeping top course of blocks back to slope the bank. Consider incorporating alternate access with a ramp for passive craft.

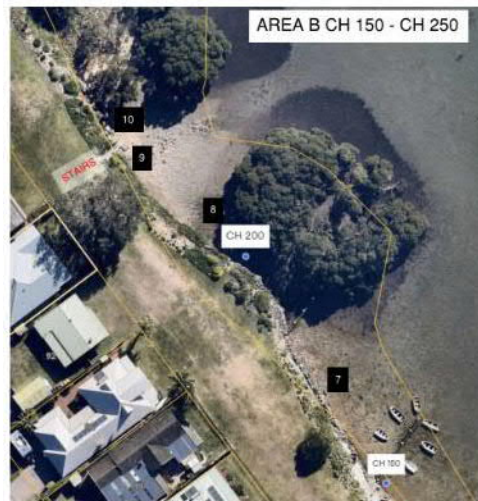
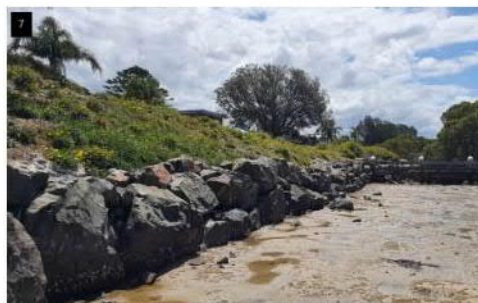
7. Rock wall with mix of large (~600mm diameter) and smaller rock. Scour along crest of wall. Areas of exposed concrete matting and geotextile. Slumping in some sections. Grout has been applied along the crest in some areas. Increase height of wall or add additional scour protection along crest. Rebuild/recycle existing rock. Install rock scour protection along toe to prevent future slumping/overturning

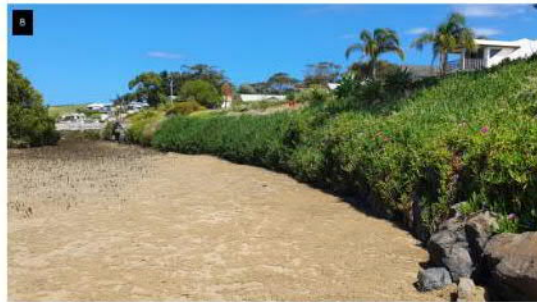
8. Well vegetated rock wall in excellent condition due to protection offered by mangroves.

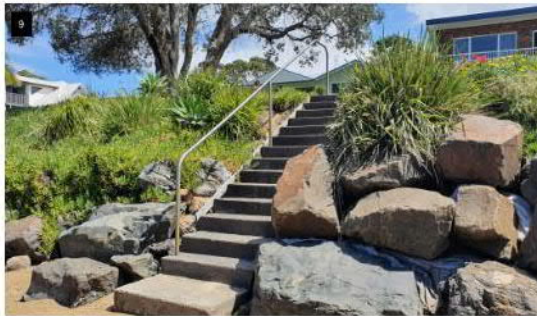
9. Concrete stairs in good condition. Add rock scour protection around base of stairs or piles.

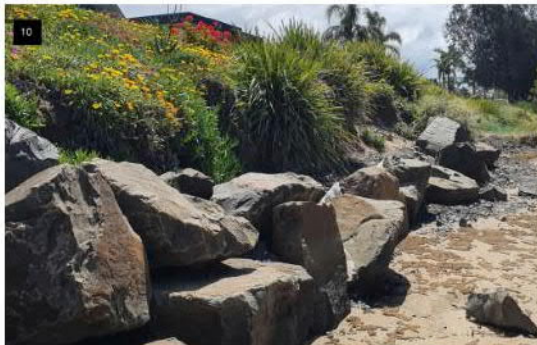
10. Slumping of rock wall adjacent to stairs. Rebuild rock revetment, two stones high on an angle (not vertical face) and add toe scour protection.

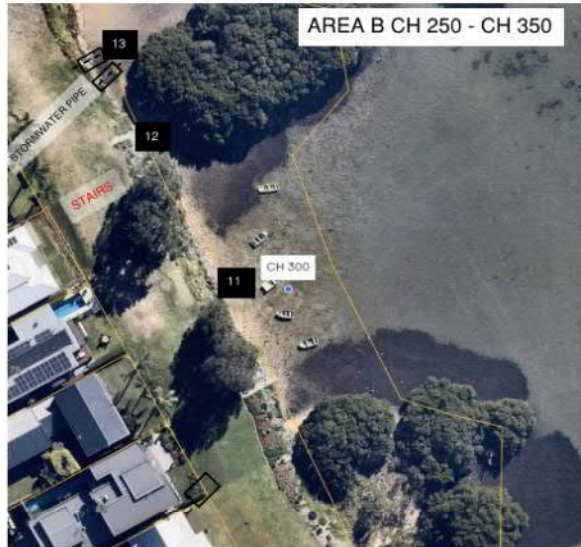
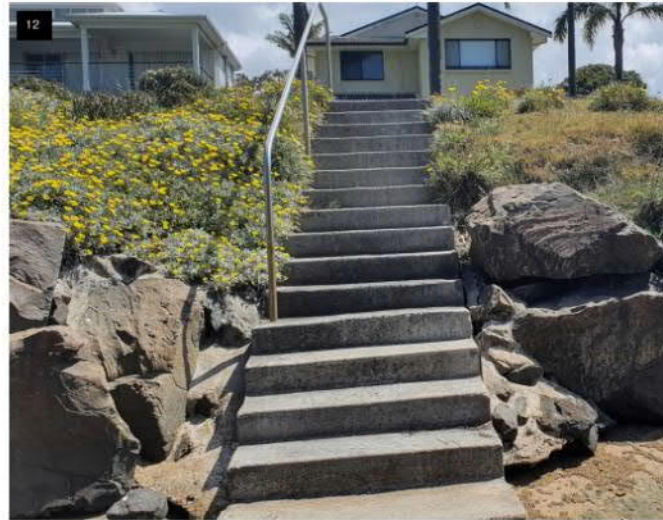
12. Concrete stairs experiencing minor settlement.  
Rebuild lower section of stairs on piles.

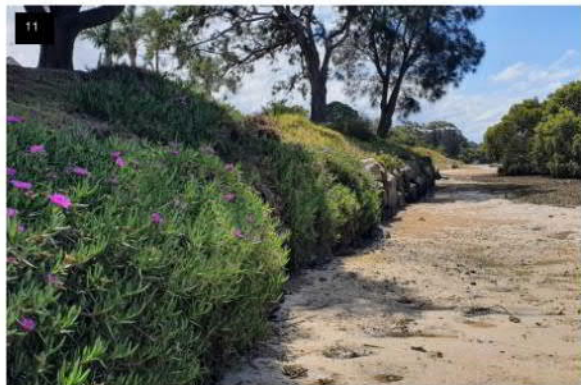
11. Vegetated rock wall in excellent condition.  
Consider adding scour protection along toe.

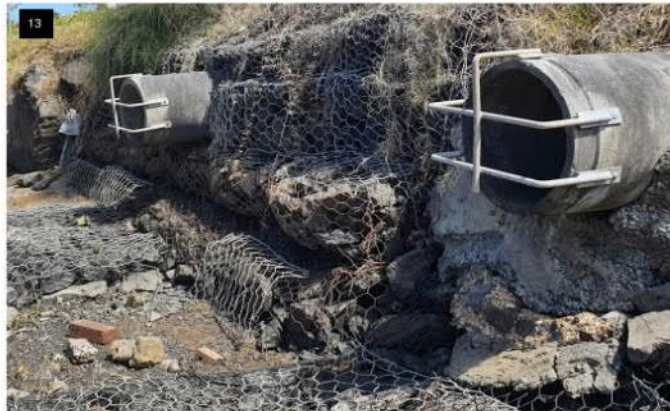
13. Two reinforced concrete storm water pipes. Gabion scour protection. Gabion baskets have been repaired and some are in need of repair.  
Consider replacing gabions with stone blocks in the future.

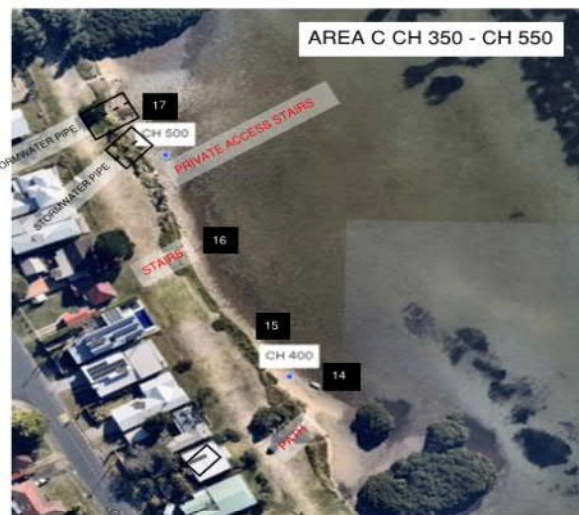
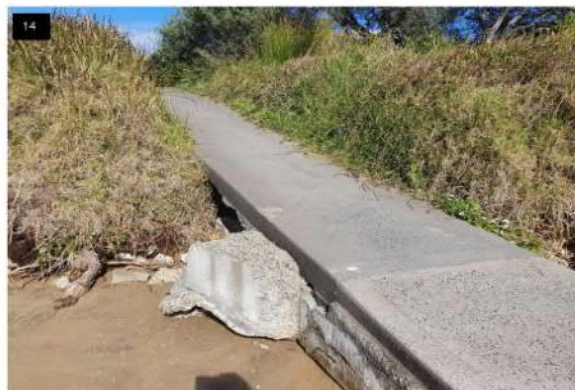
14. Concrete ramp exposed at toe and experiencing washout underneath. Erosion occurring along the downstream bank. Cutoff ramp above HWM and replace with FRP mesh on piles at end.

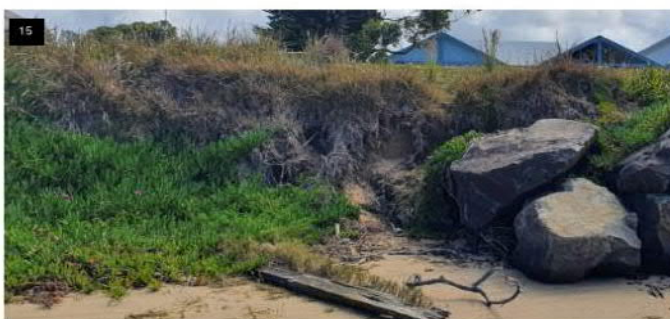
15. Slumping of bank adjacent to rock protection. Continue rock protection all the way along bank to ramp.

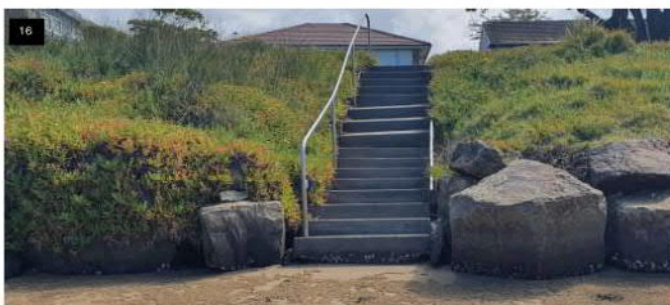
16. Rock wall approximately two stones high, well vegetated and in good condition from CH 400 to CH 500. Concrete stairs showing signs of displacement. Consider toe scour protection along extent of rock wall.

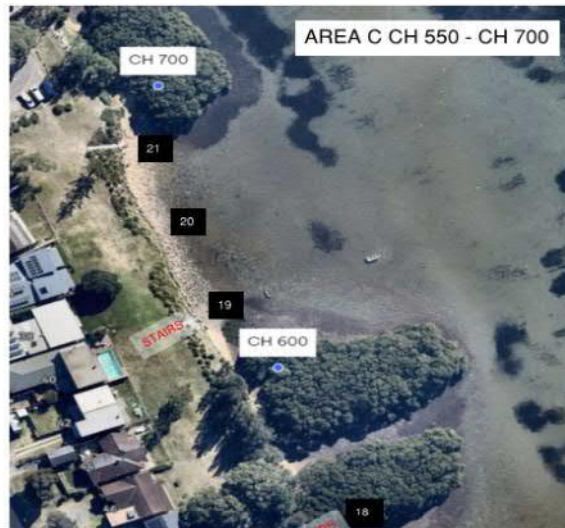
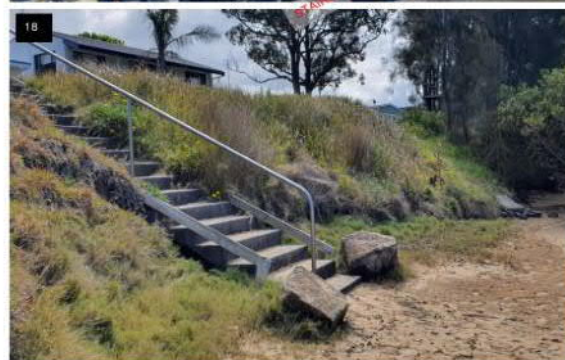
18. Concrete stairs currently in good condition. Displacement may start to occur in sections where material is being washed out from underneath. Fill under concrete stairs with concrete. Add rock scour protection at toe or alternatively place on piles.

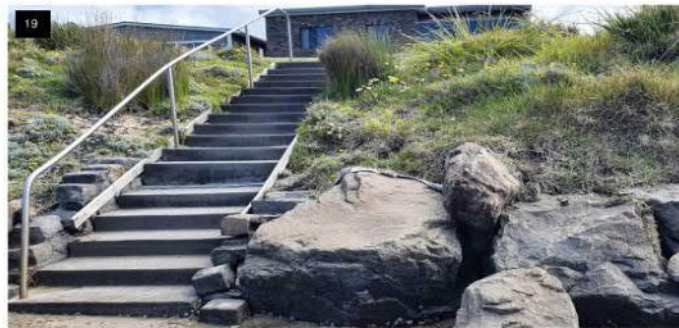
19. Minor settlement of stairs occurring. Grout has been used on the stair landing aimed at minimising further settlement. Rocks placed either side of stairs as scour protection. Material appears to be being washed out from under stairs. Replace lower portion of stairs and place on piles.

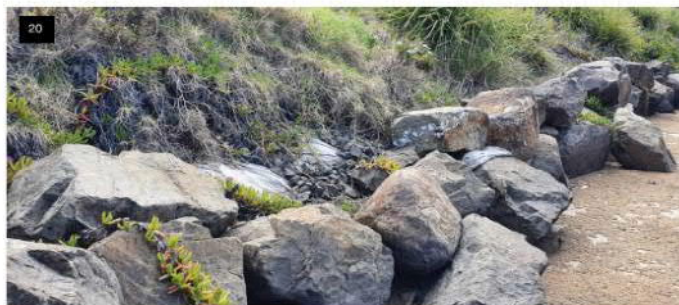
20. Erosion occurring along crest of wall. Wall height needs to be increased. Displaced rocks along extent of wall - better placement required. Rebuild wall (approx two stones high) and rock scour protection along toe.

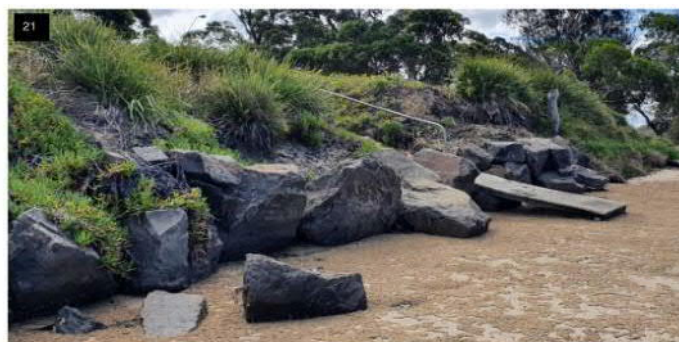
21. Concrete ramp with lower portion made from FRP. In good condition. Displacement of rocks either side of ramp and minor slumping - increase height of wall crest.
