Coastal Zone Management Plan for the Minnamurra River Estuary

Prepared on behalf of Kiama Municipal Council by Hydrosphere Consulting.

PROJECT 15-001 – CZMP FOR MINNAMURRA RIVER ESTUARY					
REV	DESCRIPTION	AUTHOR	REVIEW	APPROVAL	DATE
0	Draft for Council review	R. Campbell, K. Pratt, U. Makings	K. Pratt, M. Howland	M. Howland	12/12/14
1	Final Draft for Public Display	R. Campbell, K. Pratt	M. Howland	M. Howland	23/2/15
2	Minor edits	R. Campbell	K. Pratt	R. Campbell	28/2/15
3	Updated with Committee feedback	R. Campbell	K. Pratt	R. Campbell	31/3/15
4	Incorporating feedback from public display	R. Campbell	M. Howland	M. Howland	22/6/15

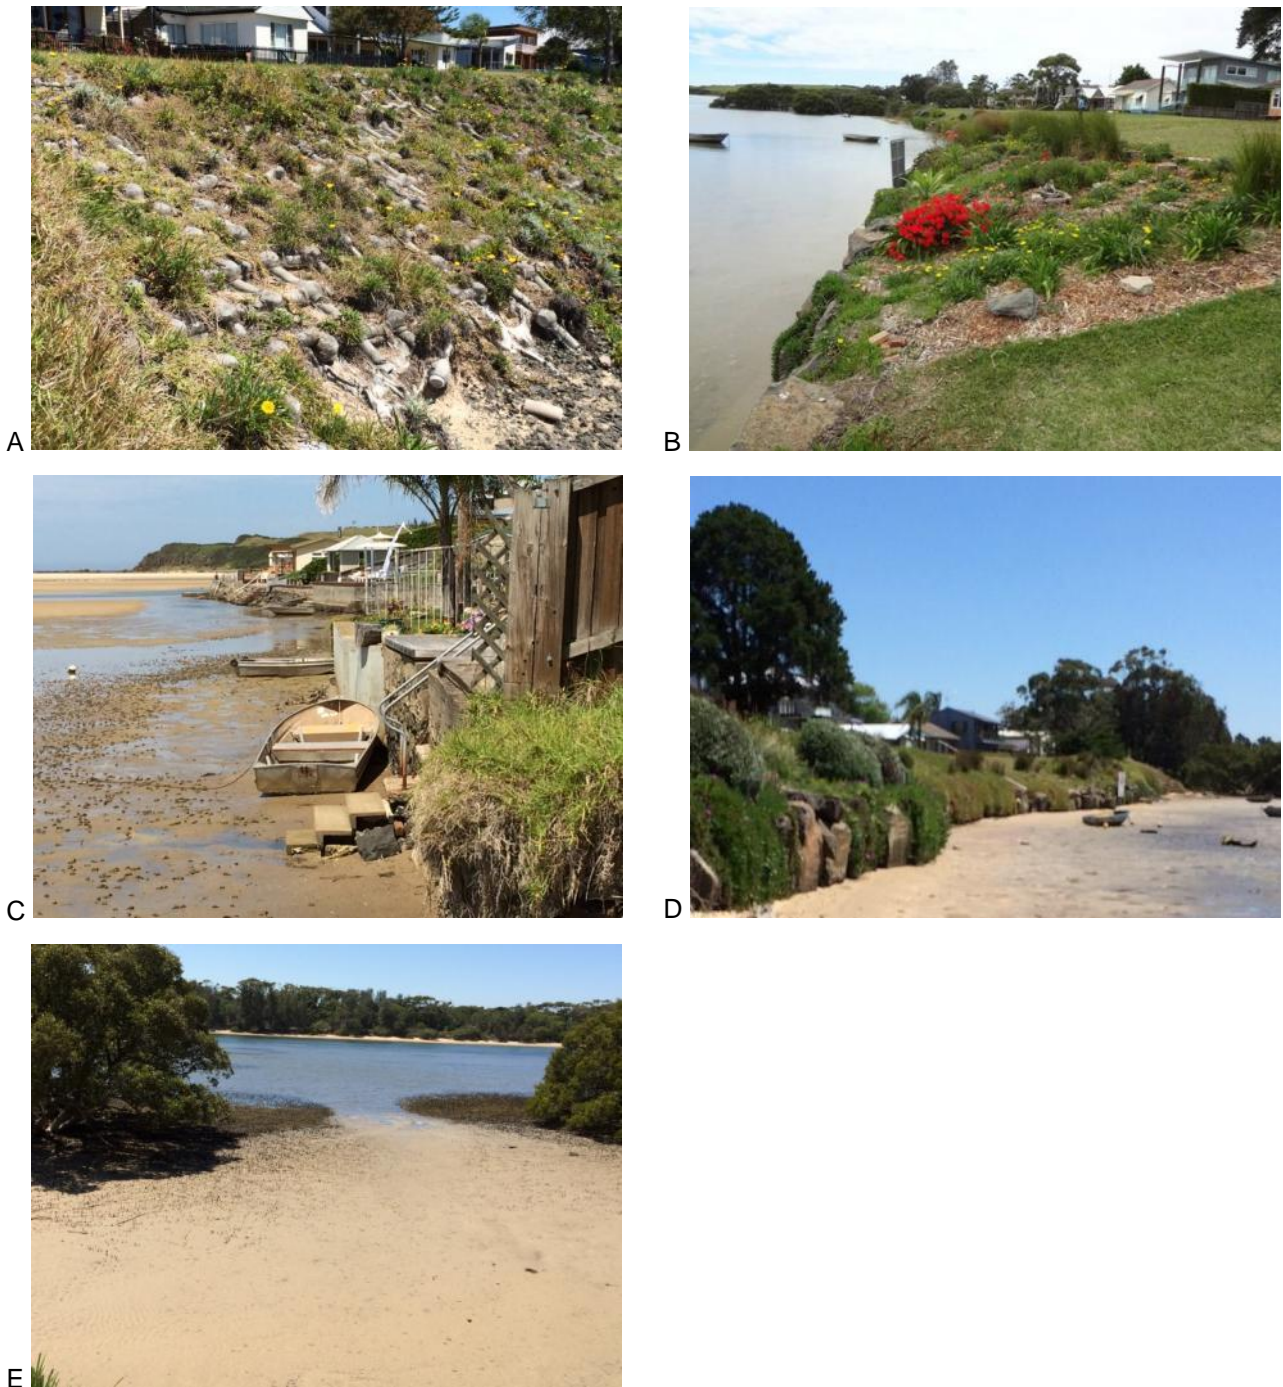
Several landowners along Charles Avenue that directly adjoin the riverbank have constructed rock, concrete and better brick retaining walls on their property boundary on the bank in an attempt to stop bank erosion. Parts of the old masonry walls are in poor condition (Figure 30). These *ad hoc* measures can be effective at curbing erosion on the stretch of bank to which they are applied however, have the potential to exacerbate erosion further along the bank.

Figure 30: Charles Avenue erosion and existing controls

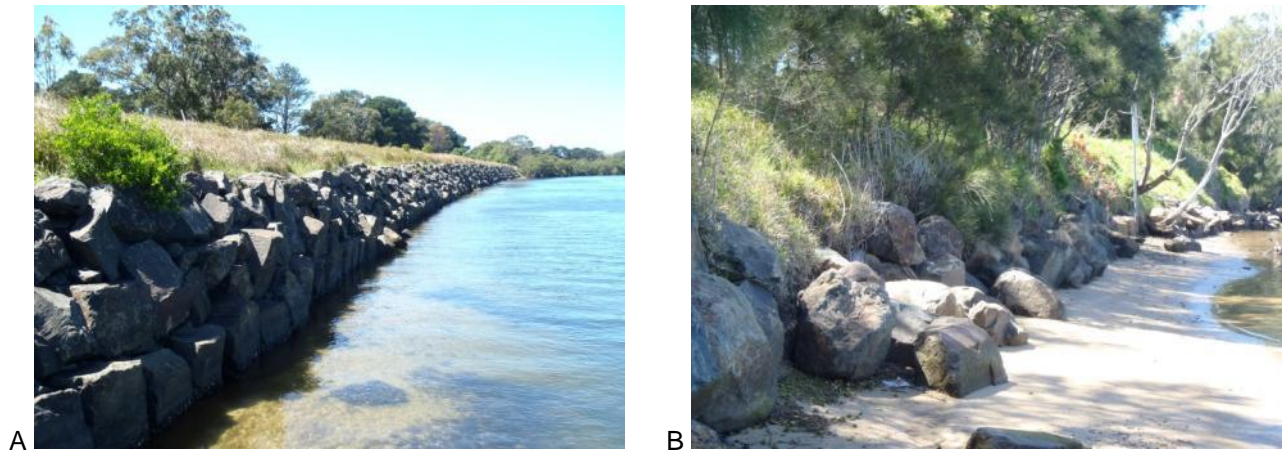
The riverbank in the vicinity of the picnic and parking area along Riverside Drive has been stabilised with rock revetment and a fishing jetty has been installed. The rock revetment in this area is steep with displacement of some large boulders (Figure 31). A lower rock revetment has also been constructed downstream of the timber access stairs.

Figure 31: Riverside Drive erosion controls

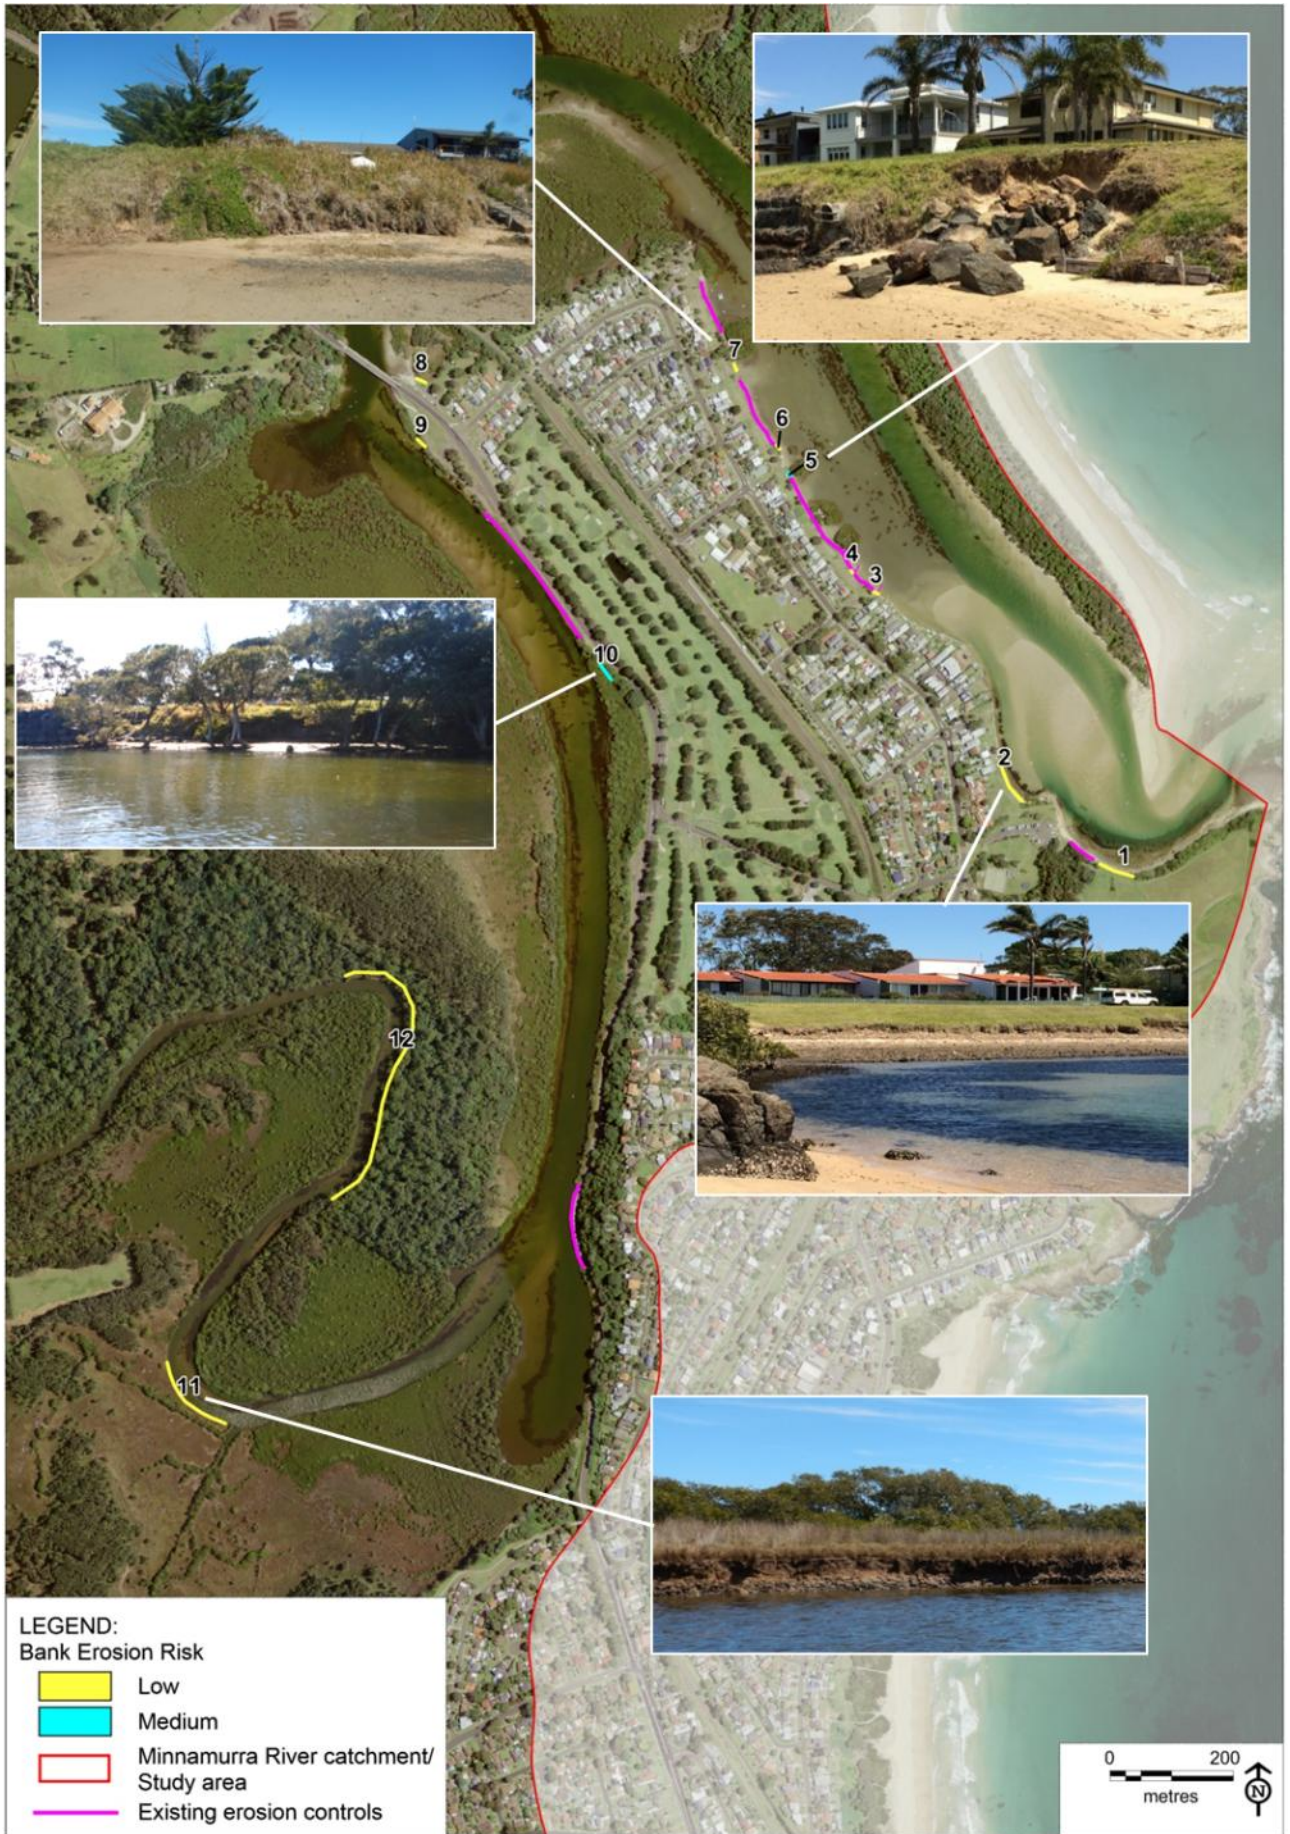
The current erosion sites, their assessed risk and example photos are shown on Figure 33, Figure 34 and Figure 35. Further detail is provided in Appendix 7.

Figure 33: Locations of bank erosion sites in the lower to mid-estuary

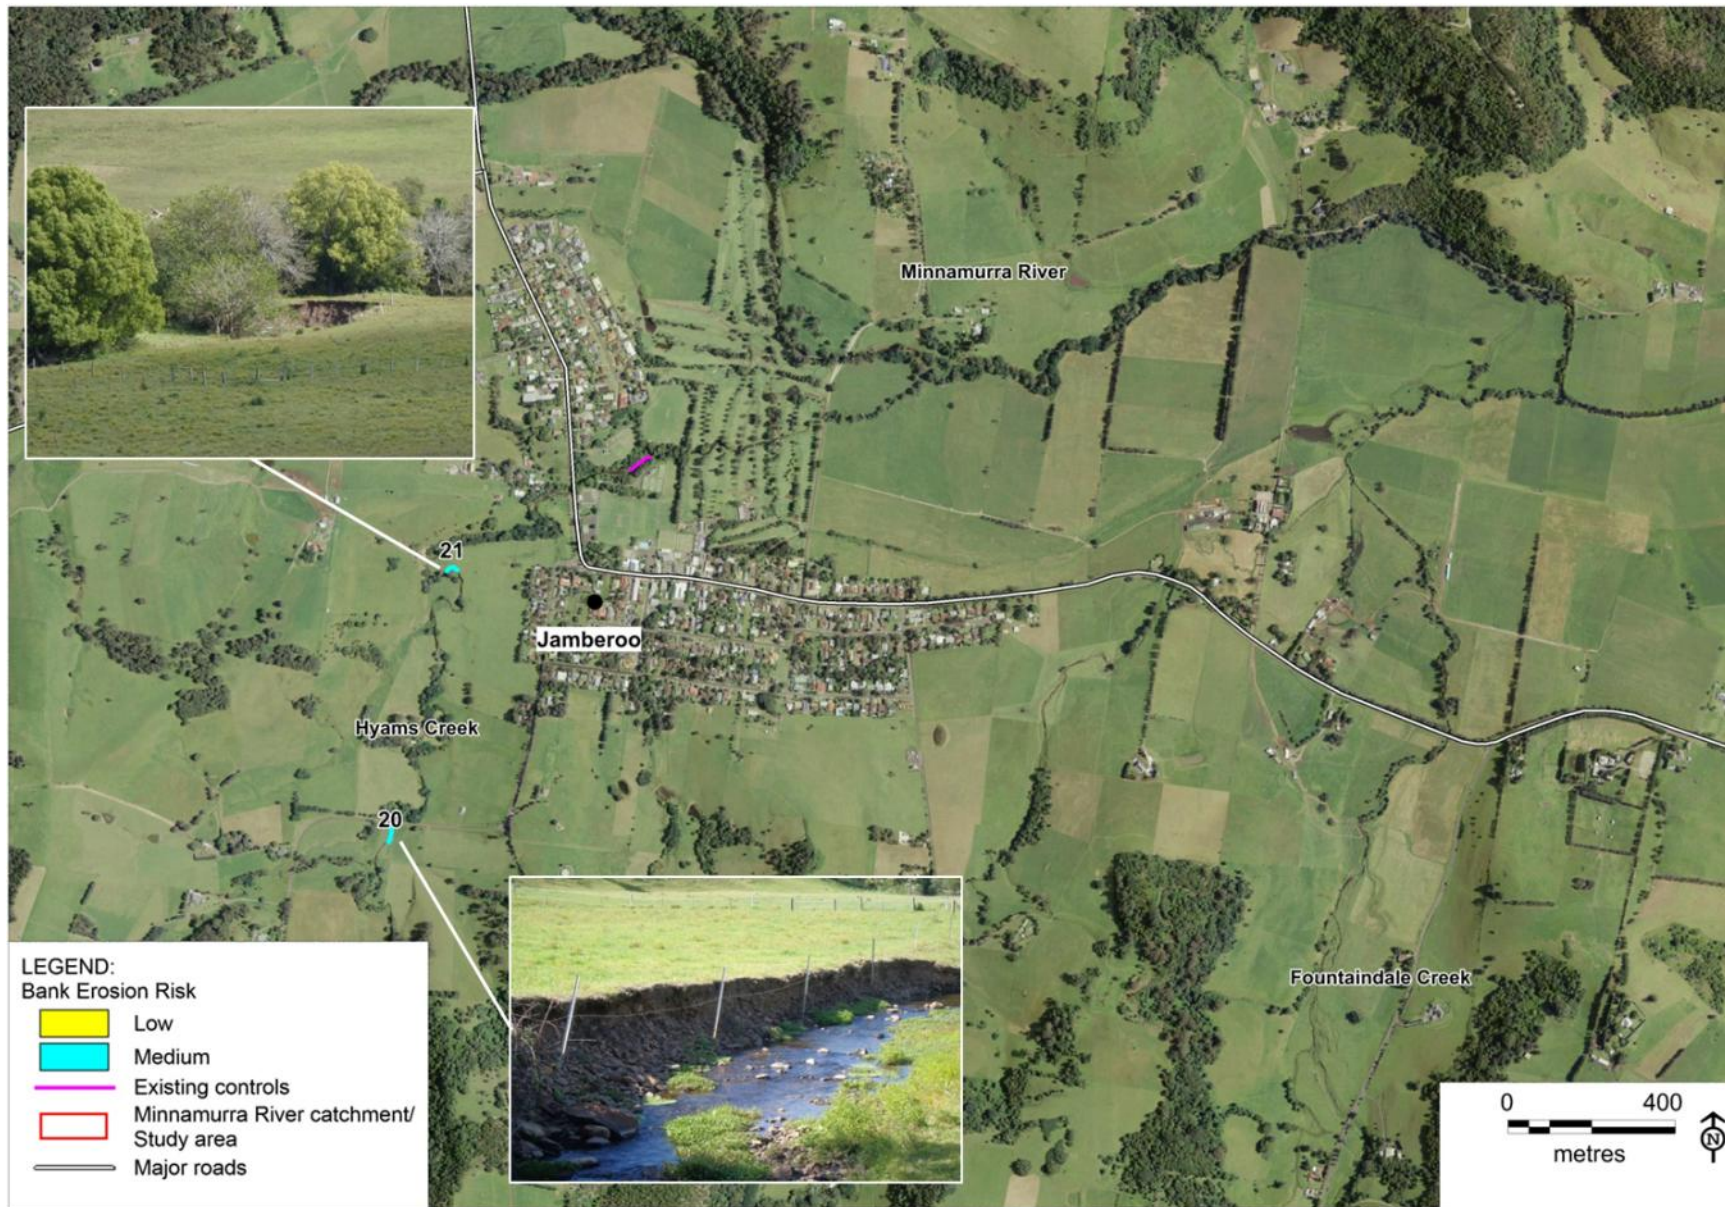
Figure 35: Locations of bank erosion sites in Hyams Creek

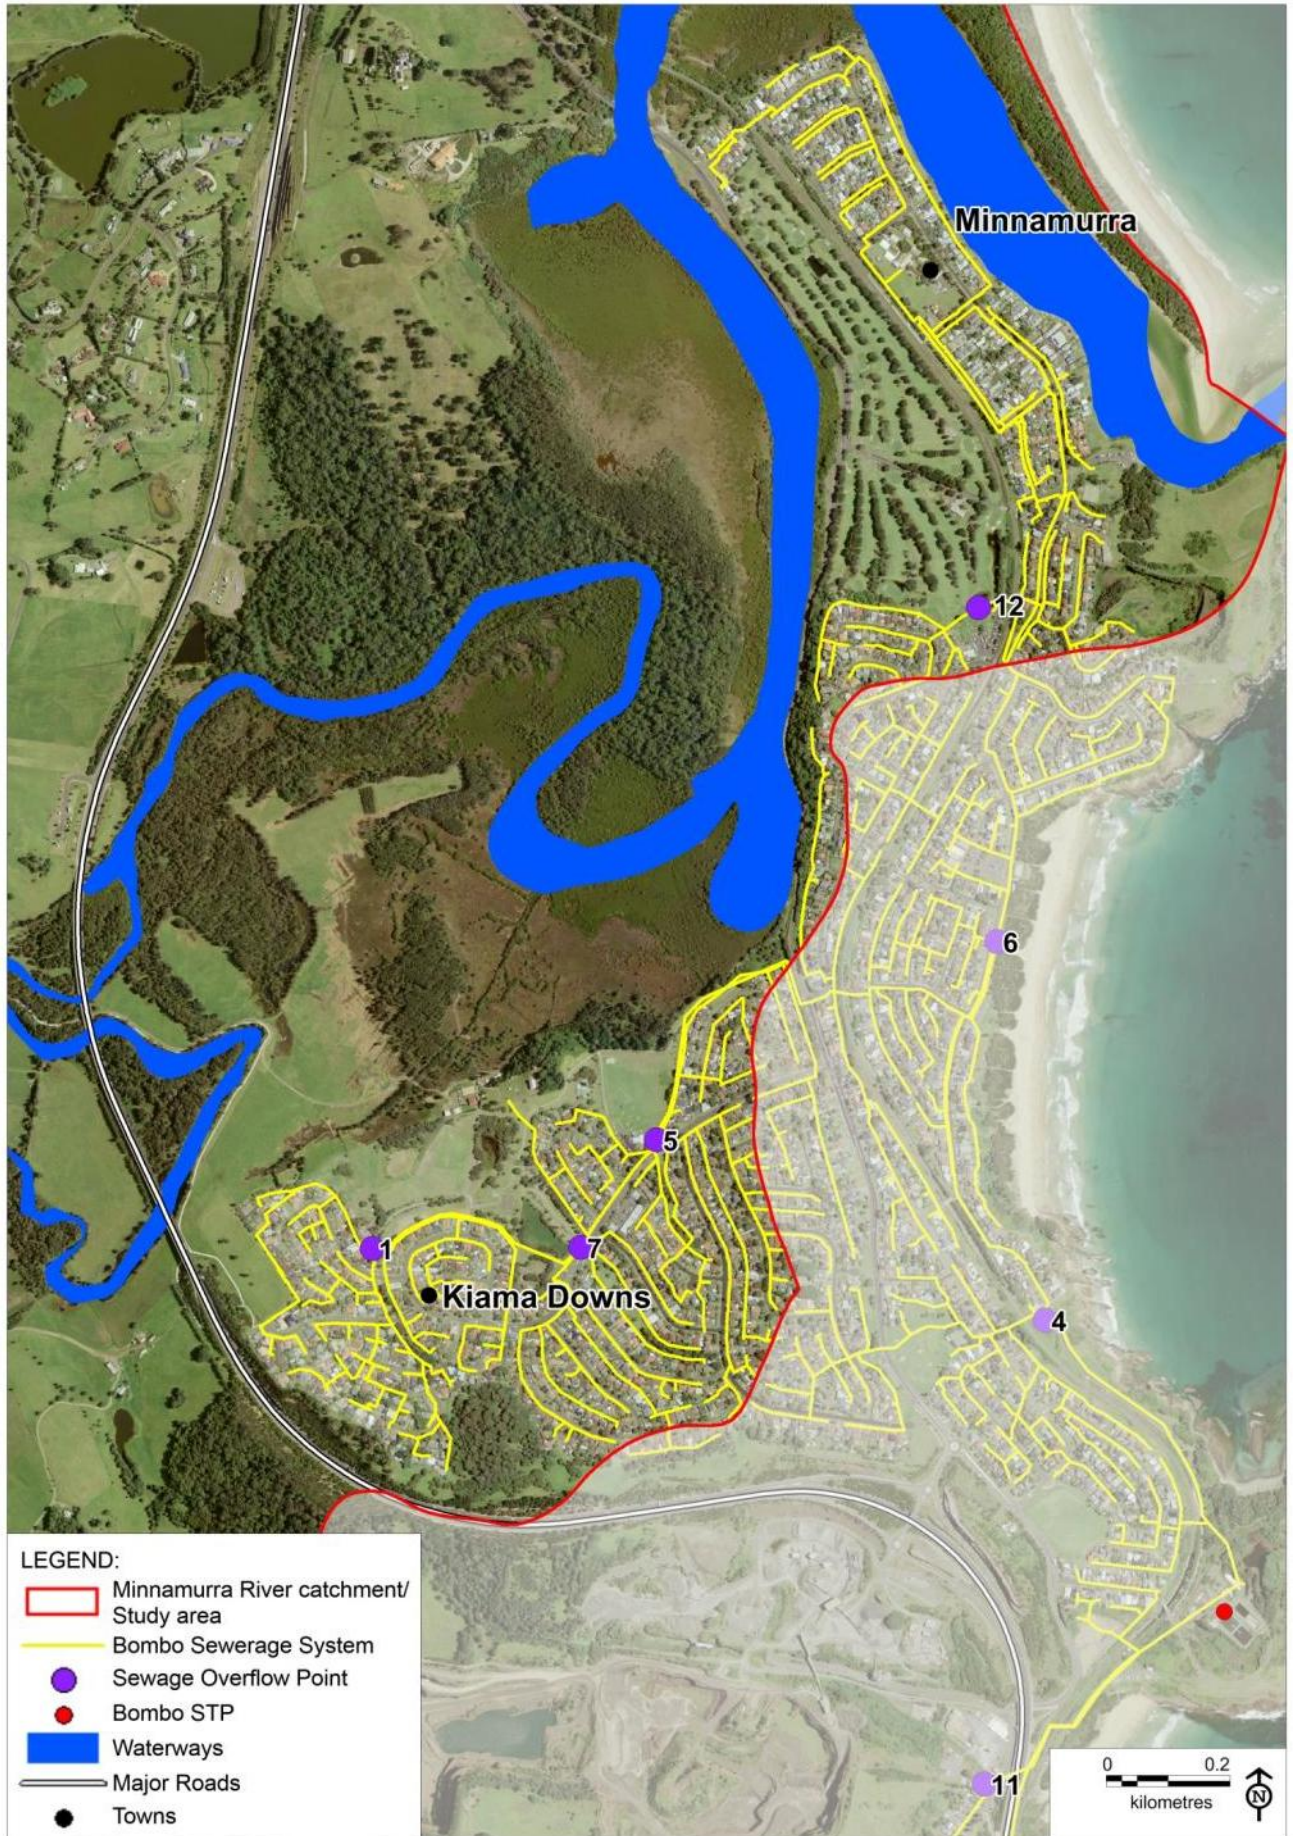
Figure 40: Minnamurra and Kiama Downs sewerage system

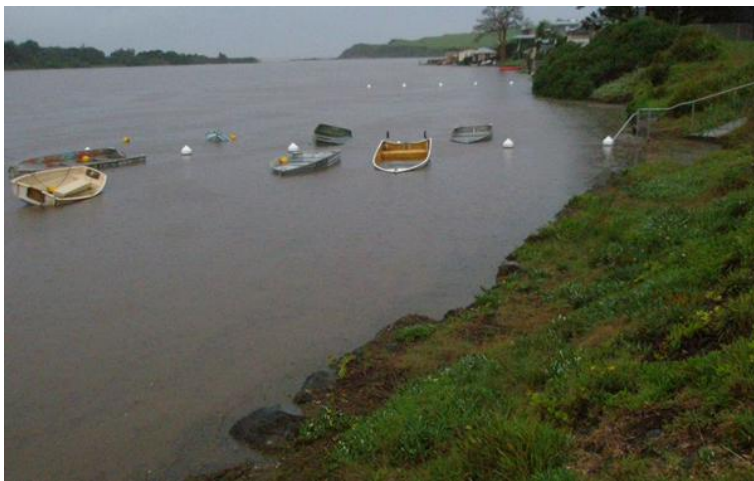
Figure 44: High river levels at Charles Avenue foreshore during floods (11/3/2011)

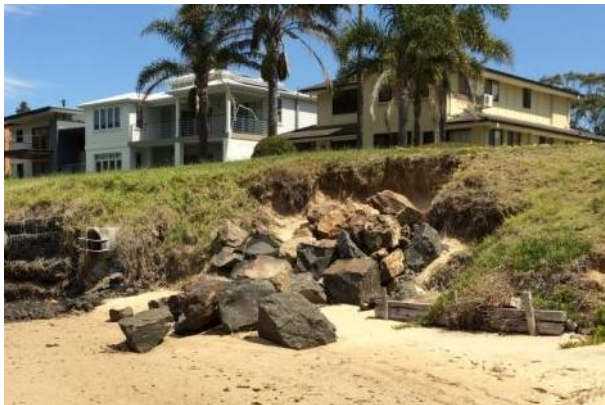
Site 5 – Charles Avenue foreshore (this site has been repaired)
