Preliminary Landfill Gas Risk Assessment Former Gerroa Landfill

Report E2W-025 L001 v1

12 January 2021

Re: Preliminary Landfill Gas Risk Assessment – Former Gerroa Landfill

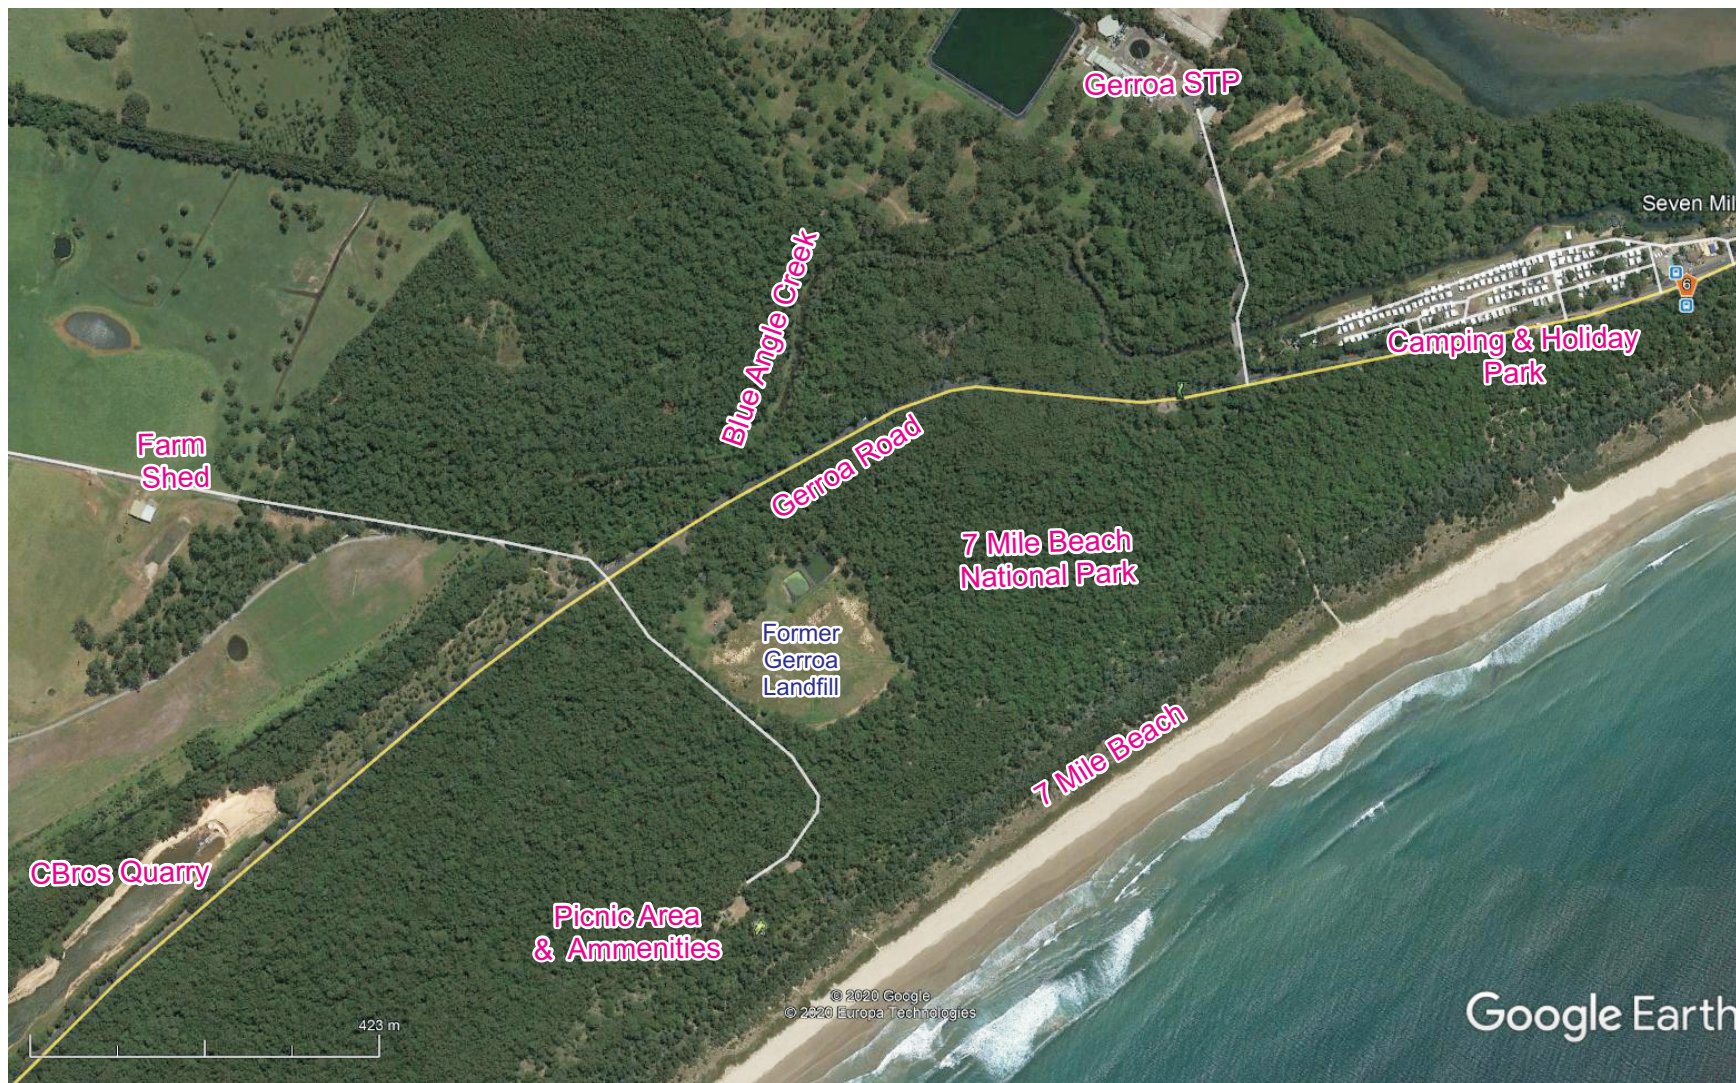
Figure 3

E2W preliminary risk assessment is based on the development and assessment of the source-exposure pathway-receptor linkages. The landfill site and surrounding areas are highlighted in Figure 3. The site is surrounded by a National Park and has no sensitive receptors within 250 m.

Gerroa Landfill- Risk Assessment for Landfill Gas (4 Jan 2021)

- **Exposure Assessment:** The preliminary assessment (4-1-2021) indicates a low potential for gas risk to onsite/offsite commercial workers, the general public or nearby farmers (Tables 1 to 3, no methane detected in ambient air, soil spikes or monitoring wells). Given the age of the landfill, sandy soils, surrounding national park, and shallow water table at the site the potential for horizontal migration of gases is interpreted to be localised and limited.

- **Risk Characterisation:** Low risks are indicated by the low gas testing results on 4 January 2021 and remote site location. Risk to human health is interpreted as very low/negligible as the site is locked, vacant and not used by the general public. The risk should be re-assessed during different climatic conditions such as during periods of hot dry weather which favour
