Appendix D Cliff and Slope Instability Walkover Field Survey

From:	Madelaine Broadfoot, Paul Donaldson	To:	Kiama CMP Team
Date:	22 November 2019	CC:	Byron Robinson
Subject:	Geomorphological Walkover Field Survey and Preliminary Cliff/Slope Instability Exposure Assessment: Kiama's Rocky Coastline

1.1 Overview

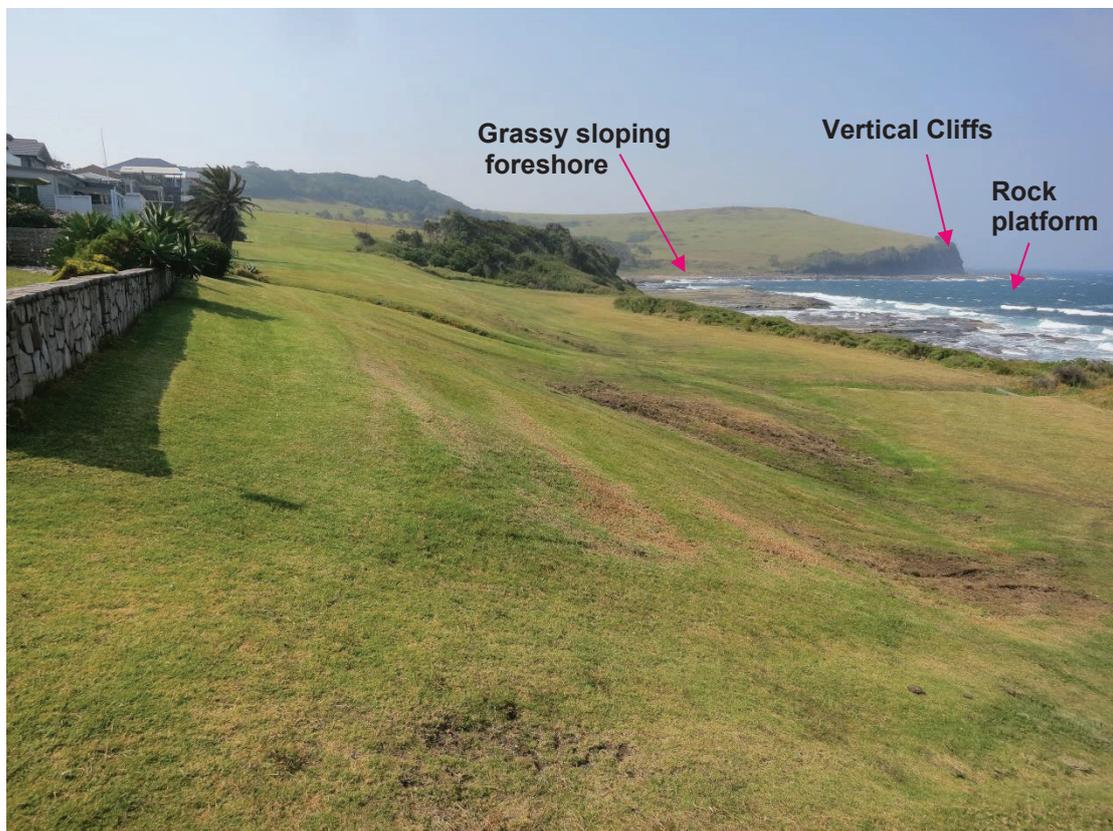
Geotechnical Summary	
Overview	<ul style="list-style-type: none"> • Gerroa to Gerringong Farmland forms a rocky coast that extends in a south-north direction, this stretch of coast encompasses both Walkers and Shelly beach backed by the Gerringong Golf course and farmland. • No significant assets are located along this stretch of coast.
Geology	<p>Rocky headland areas</p> <ul style="list-style-type: none"> • Westley Park Sandstone <p>Coastal barrier (Walkers Beach)</p> <ul style="list-style-type: none"> • Dune, beach and shoreface sands
Geomorphology	<ul style="list-style-type: none"> • Grassy sloping foreshore, which transition into with vertical cliffs and wide rock platform towards the north (Figure 8).
Coastal Cliff / Slope Processes	<ul style="list-style-type: none"> • N/A
Asset Exposure Summary	
Overview: Coastal Fringing Assets	<ul style="list-style-type: none"> • No fringing assets only farmland and golf course

Figure 8 Gerroa to Gerringong Farmland

Recommendation	
	<ul style="list-style-type: none"> • N/A

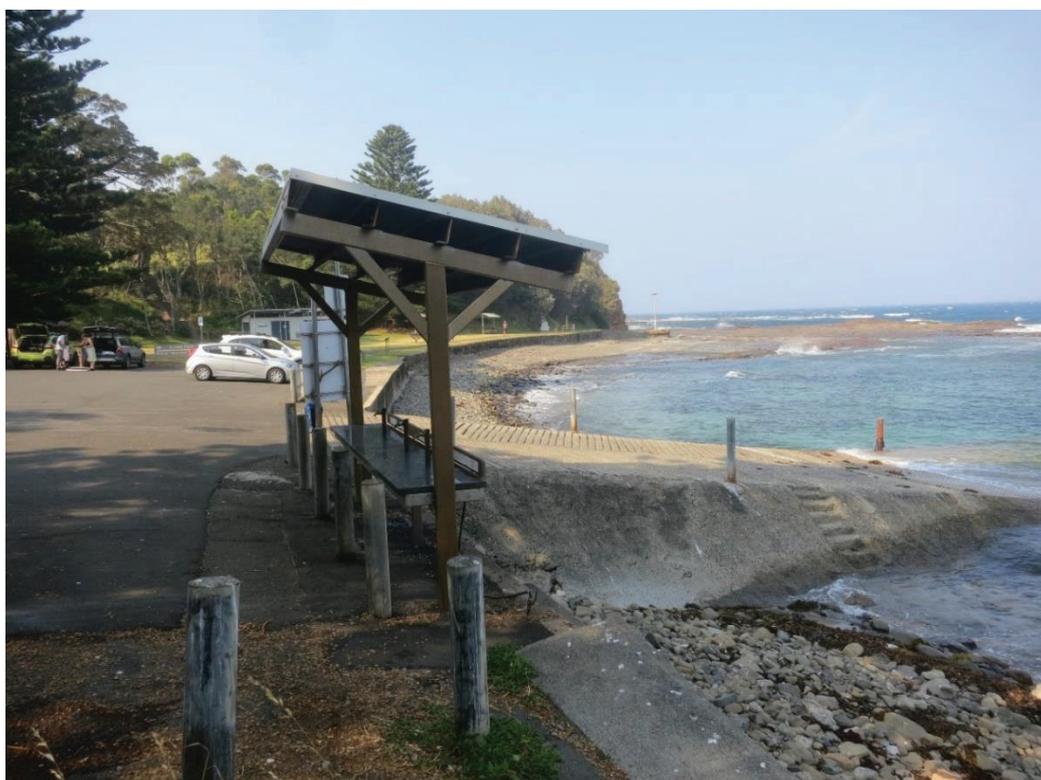
Asset Exposure Summary	
Overview: Coastal Fringing Assets	<ul style="list-style-type: none"> No significant assets were observed to be exposed during the site visit.
Recommendation	
	<ul style="list-style-type: none"> N/A

Figure 9 Amenities and works at northern end of Gerringong Harbour

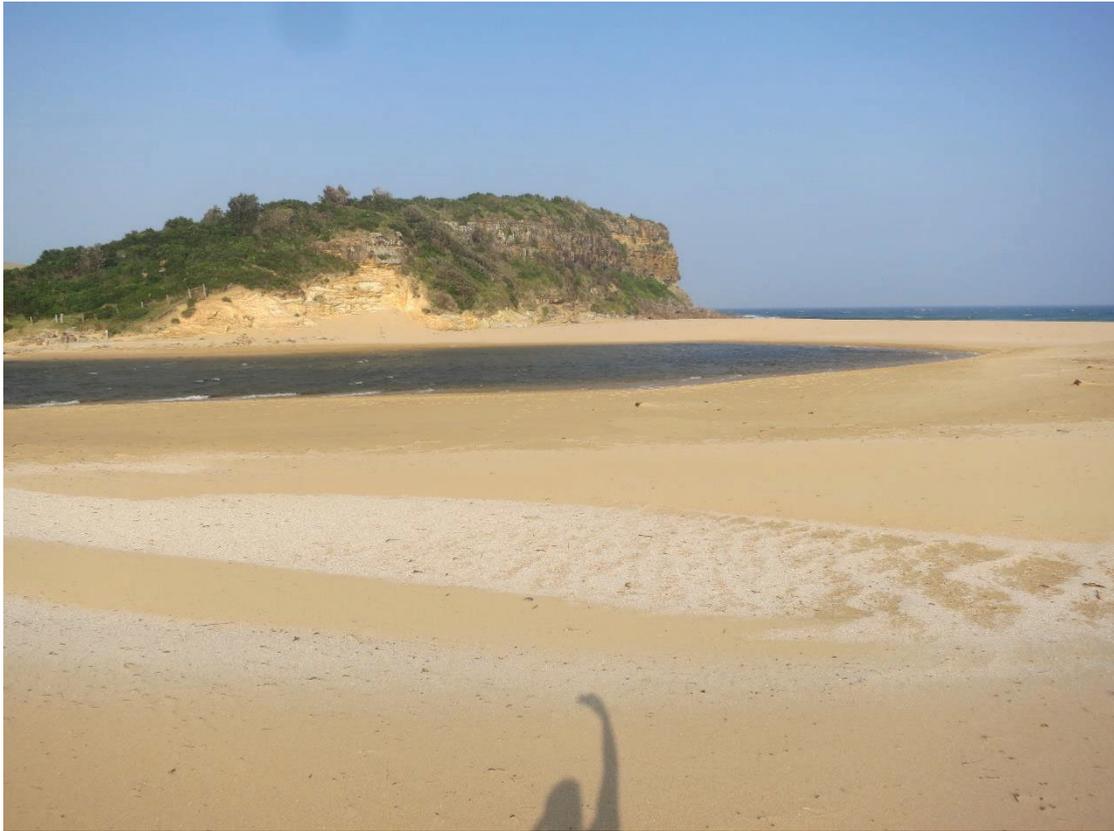
Infrastructure and public Assets: Road, foot path and car park on Pacific Ave	<ul style="list-style-type: none"> Infrastructure located on the foreshore is potentially built on the same sediments as the south Werri Beach car park. Additionally, the proximity to wave action indicates possible exposure to undercutting and slumping by wave action. Area is possibly partially supported by bedrock, but may require further geotechnical investigation to confirm risk. Erosion risk has been identified in erosion mapping see Section 3 Coastal Erosion and Shoreline Recession
Recommendation	
South Werri Beach Car park	<ul style="list-style-type: none"> Monitor erosion of adjacent shoreline. If shoreline erosion occurs and threatens the car park asset, a more detailed geotechnical assessment may be warranted to determine the erosion susceptibility of the car park.

Figure 11 North Werri Beach Headland

Geotechnical Summary	
	<ul style="list-style-type: none"> Formalised toe protection works of the car park fronting the rocky slopes, may be warranted.
House on Geering St	<ul style="list-style-type: none"> Require a geotechnical assessment for new development or extensions proposed where allotment boundaries adjoining the bluff slopes are located adjacent coastal hazard zones. Residents can monitor dwellings for signs of movement (e.g. formation of crack in brick work)
Road, foot path and car park on Pacific Ave	<ul style="list-style-type: none"> Monitor erosion of adjacent shoreline. If shoreline erosion occurs and threatens the car park asset, a more detailed geotechnical assessment may be warranted to determine the erosion susceptibility of the car park.

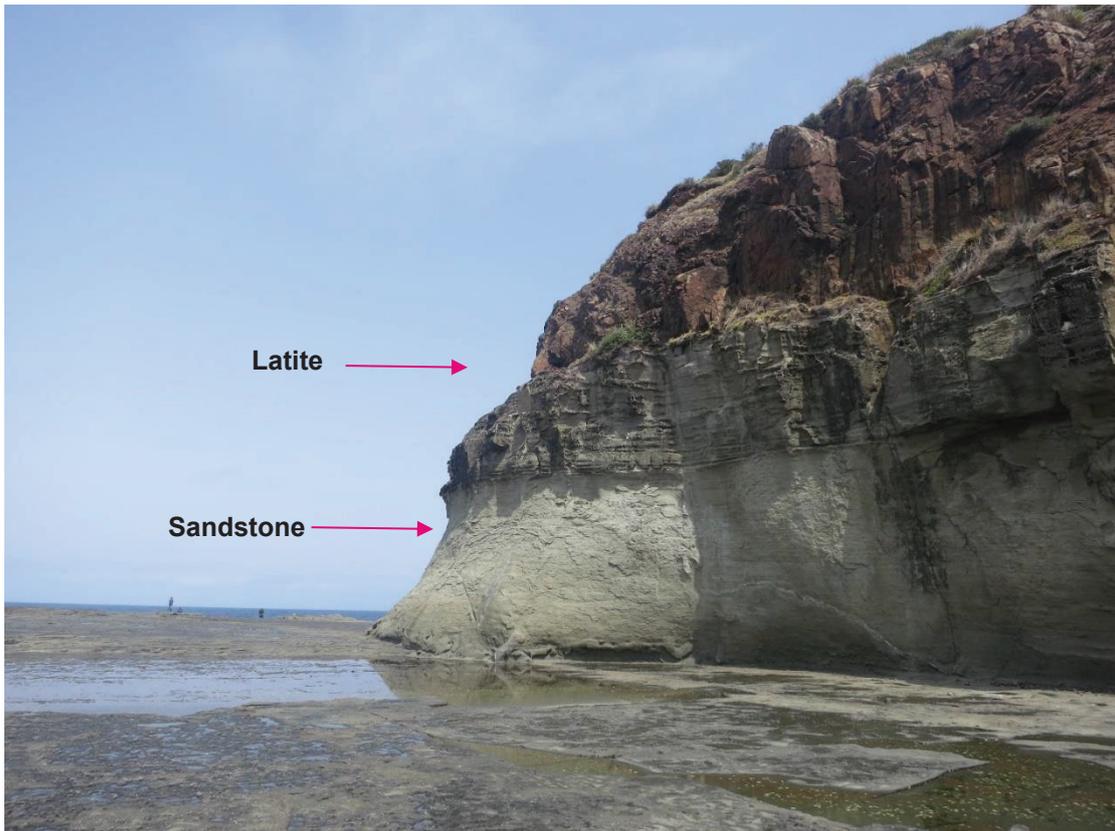
Figure 16 Blow Hole Latite over laying sandstone

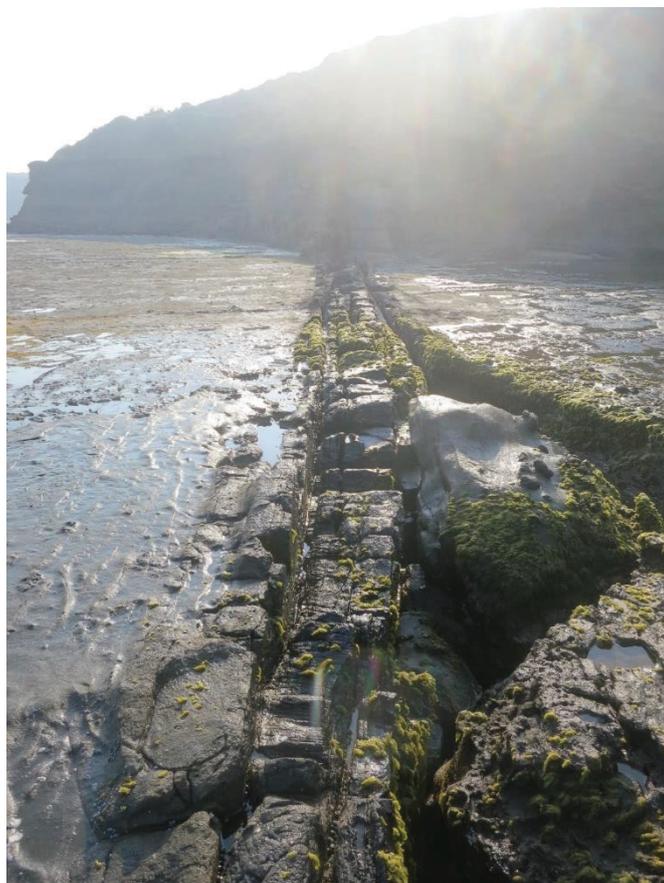
Figure 17 Igneous Dyke Intrusion

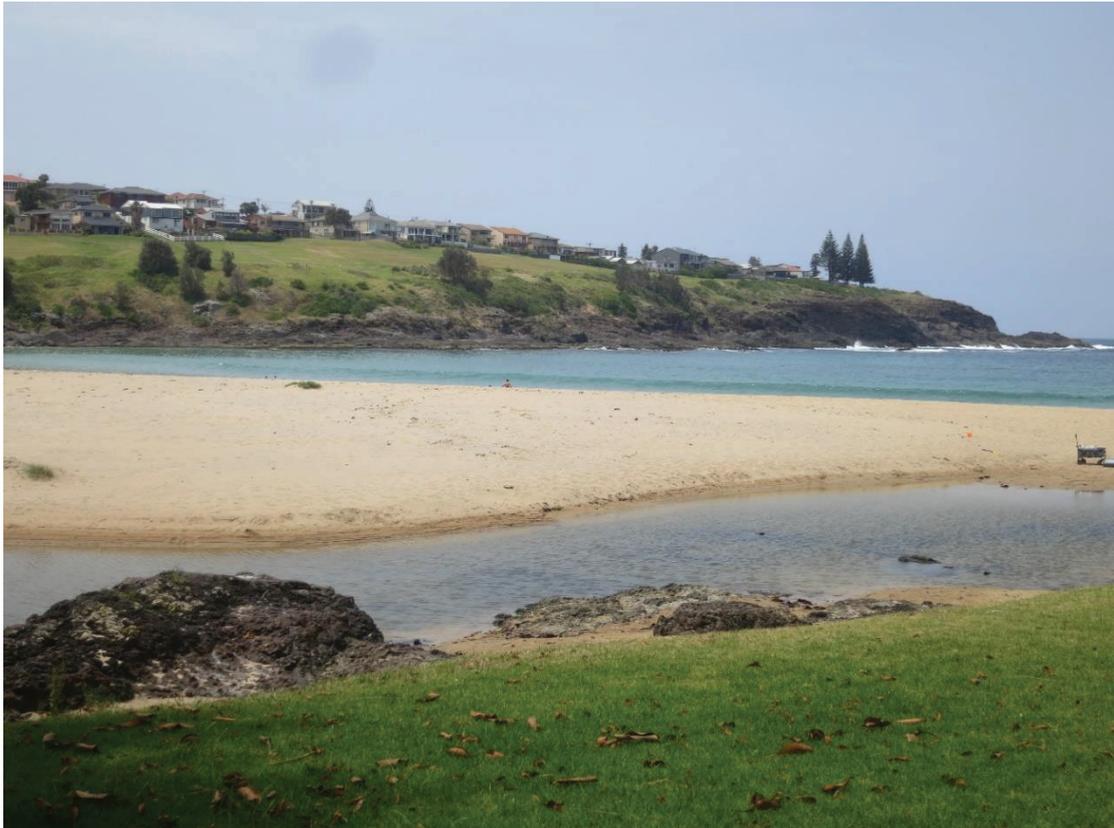
Asset Exposure Summary	
Overview: Coastal Fringing Assets	No exposure- stable sloping profile with private assets set back from the coast. The only Big4 asset identified to have a potential exposure appears to be built on bedrock (Figure 21).
Recommendation	
	<ul style="list-style-type: none"> • N/A

Figure 18 Easts beach (Marsden Head), stable rocky sloping profile with private assets set back from cliff face.

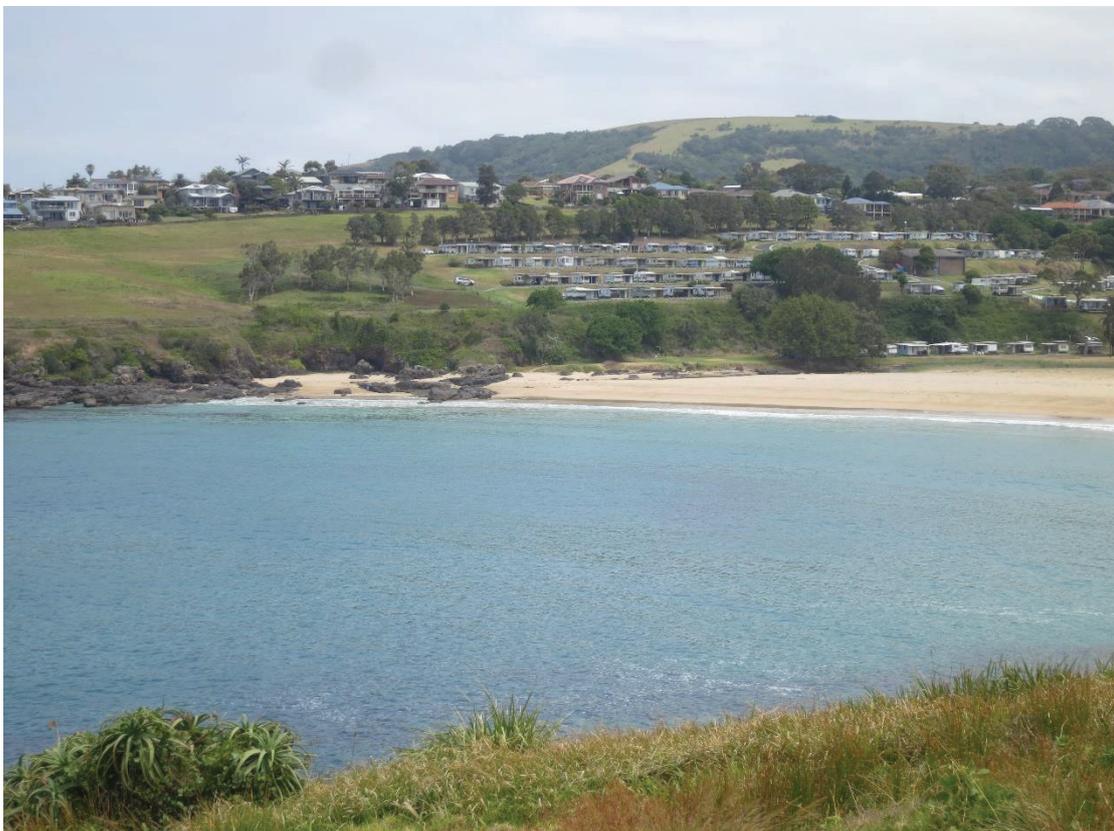
Figure 19 Easts beach (unnamed headland), grassy and rocky sloping profile with private assets set back from cliff face.

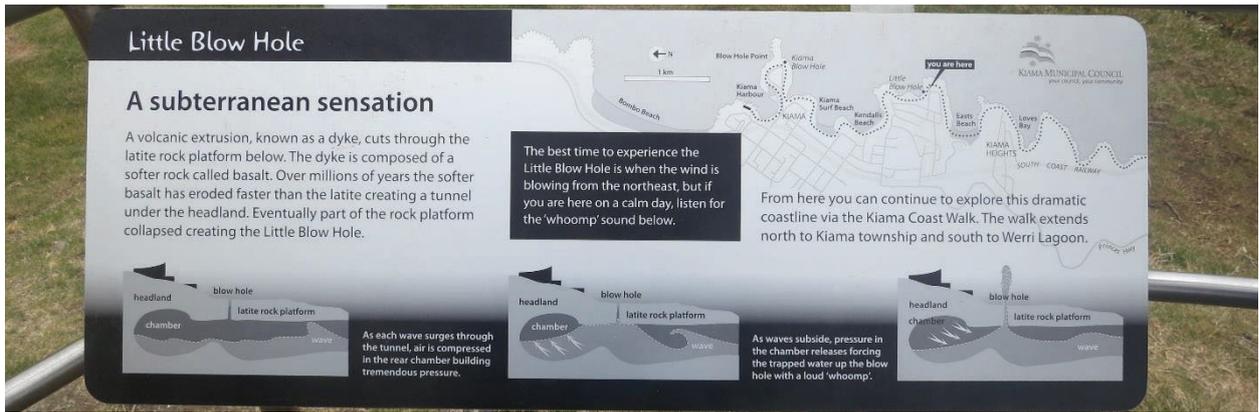
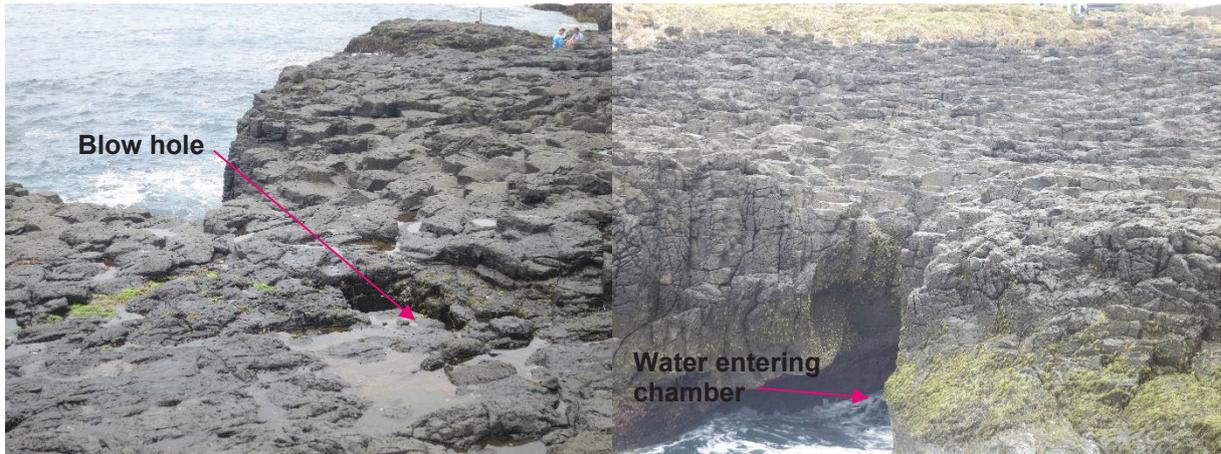
Figure 22 Little Blow Hole

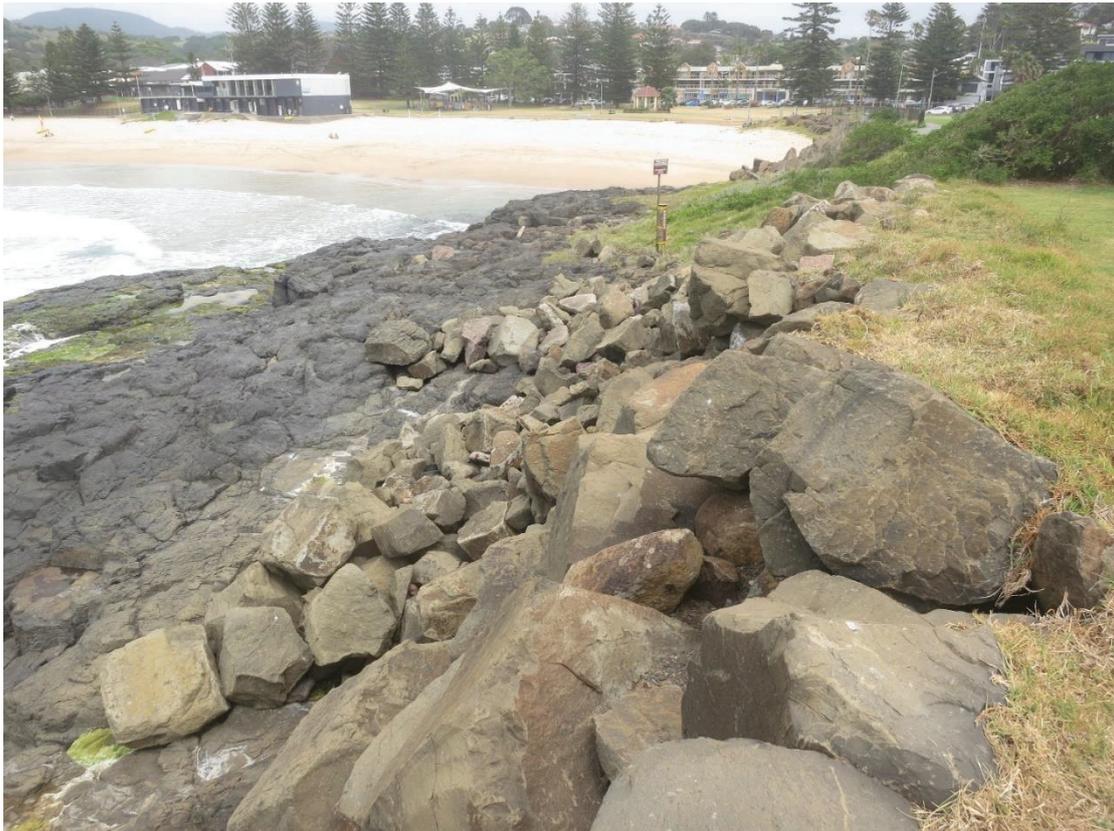
At the showground and shared footpath on Church Point, evidence of slope movement exposing fill in places was observed, particularly where slope stabilisation works were absent. Recreational assets are at risk if slope continues to move in areas with over steepened slope profile (e.g. northern side of Church Point) and slope adjustment may expose sections of shared footpath and edges of the showground to geotechnical instability. Additionally, cracking of the shared footpath was observed on the southern side of Church point indicates slope movement. It is recommended that the cliff top pathway be further monitored for evidence of slope movement (e.g. cracking), a site specific geotechnical assessment is warranted, if this occurs.

Figure 29 Protection works on the south side of Church Point

Geotechnical Summary	
Private & public Assets: Campground pool & footpath	<ul style="list-style-type: none"> • Monitor cliff top pathway for evidence of slope movement (e.g. cracking). A site specific geotechnical assessment is warranted, if this occurs
Public Assets: Showground and shared footpath	<ul style="list-style-type: none"> • As above

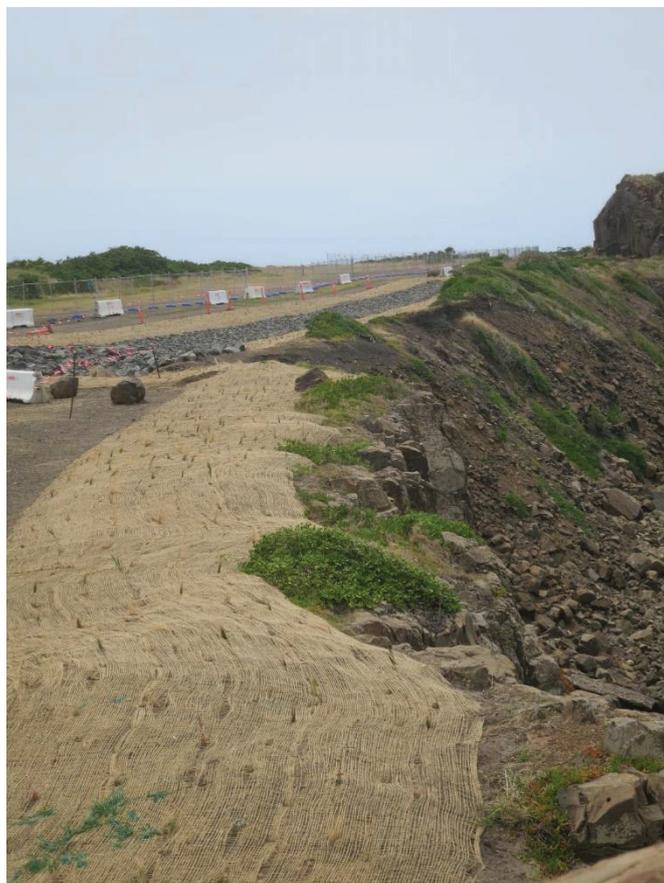
Figure 41 Works being undertaken during the time of the assessment, Bombo Headland

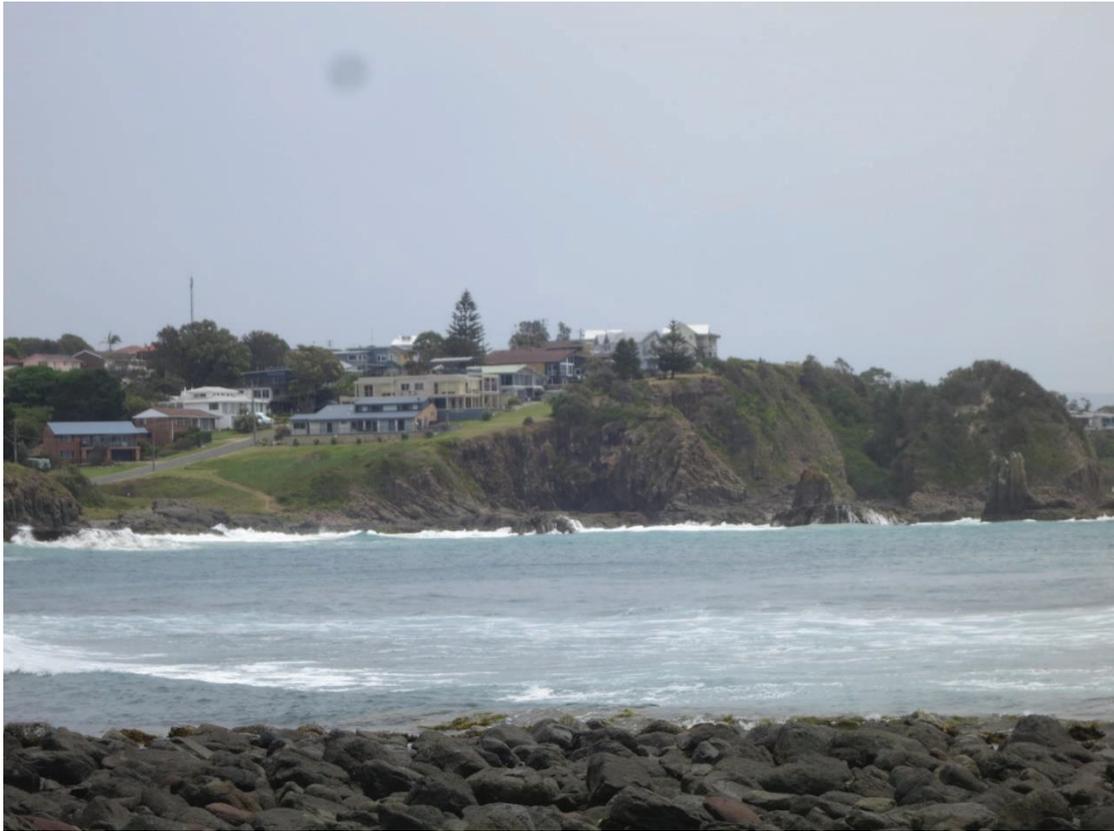
Figure 42 Cathedral Rocks

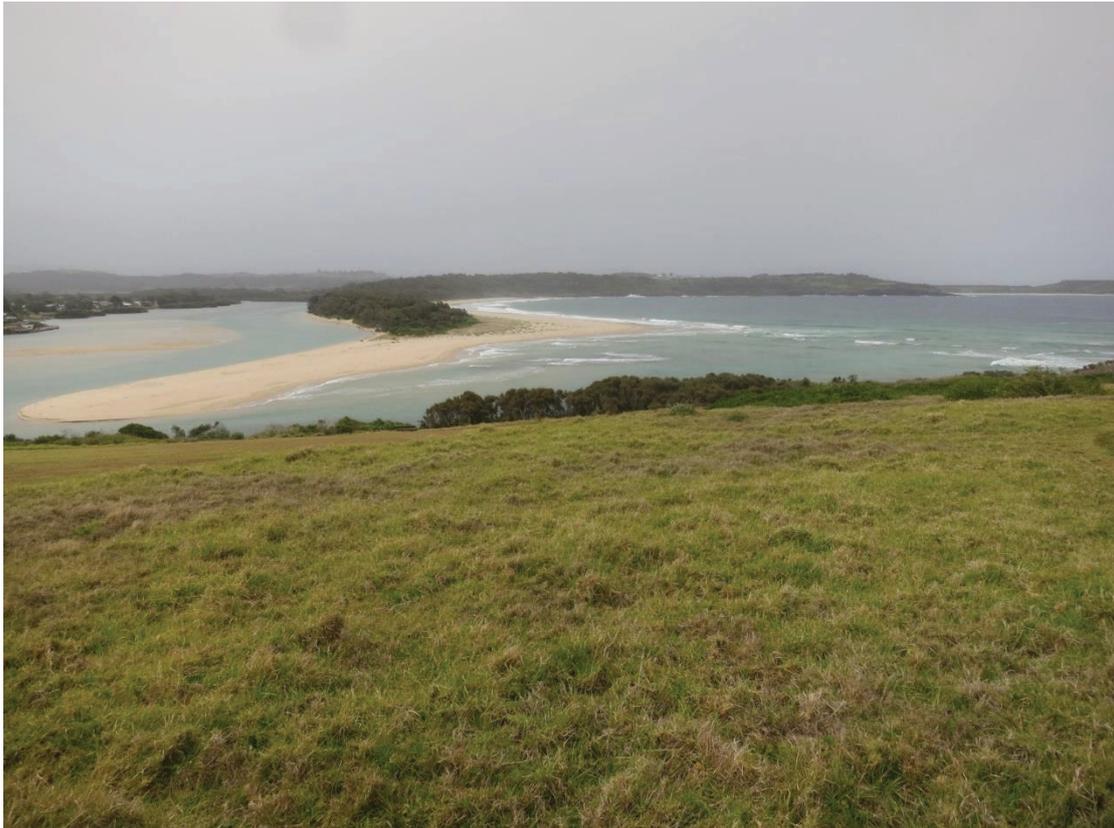
Figure 47 Minnamurra river entrance and reserve
