# Minnamurra Rock Wall Assessment

## Concept Design Report

Kiama Municipal Council

311010-00189

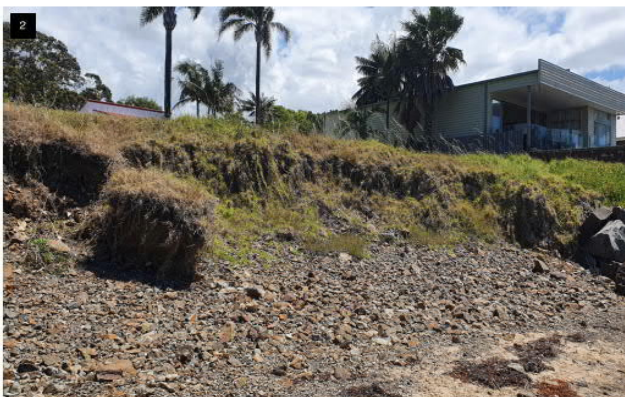
Figure 4-1 Shoreline Protection Area A Extending from Chainage 0 to 100 m

2. Bank erosion, scarp ~1m high. Add riprap, rock pool or beach nourishment along extent of shoreline as per concept options provided. Vegetate crest with pigs face or similar to sprawl over edge as existing elsewhere. Alternatively, can consider a salt marsh berm in the riprap design.

NOTE: At CH 0 established mangroves are to be protected as they are offering protection to the bank and allowing the accumulation of sediment.
